REPORT OF REFURBISHMENT OF ENCLOSURE III AT KACHUA PUNARVAAS KENDRA, SARNATH

ACTIVITY UNDER COMPONENT IV (RESCUE AND
REHABILITATION) OF THE WII-NMCG PROJECT TITLED:
BIODIVERSITY CONSERVATION AND GANGA REJUVENATION

November 2019

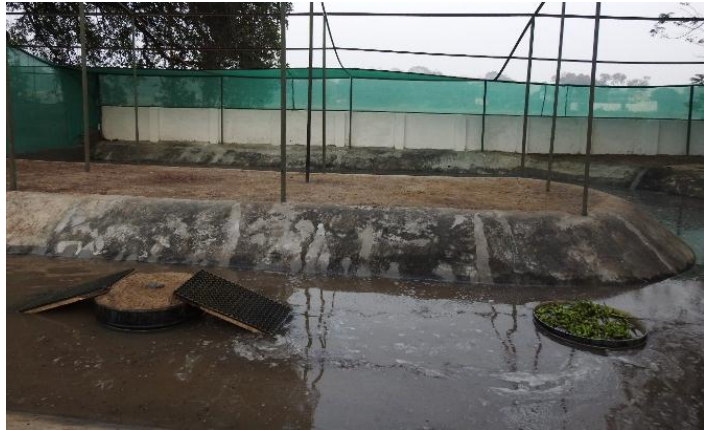
- Enclosure 3: The enclosure is in a dilapidated state and needs major repair works. It had been used for temporarily housing confiscated *Nilssonina gangetica* after carrying out minor repairs during 2018-2019. Enclosure III has a total length of 152 feet and a width of 51 feet while the depth is 5 feet. The modifications carried out during 2018 were:

- 1) Cleaning and covering enclosure 3 with green shade cloth from all 4 sides except the roof.
- 2) Two temporary walls were built for separate the existed water body into two part and one part were made ready to retain water by temporary covering the cracks with cement.
- 3) Water supply to ensure consistent water level.
- 4) Enclosure enrichment which includes basking spots.

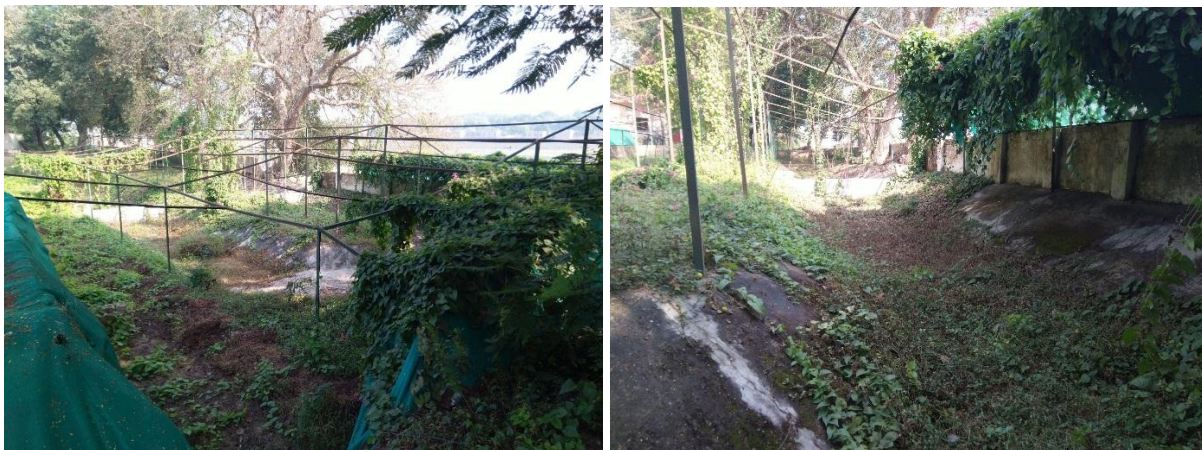
An assessment of enclosure III was carried out during visits to KPK, Sarnath and the enclosure III was observed to be in a poor state with the water body filled up with sand, water seeping through the various cracks and crevices in the structure caused by roots of vegetation and lack of maintenance and the enclosure was overgrown with weeds. It was also observed that the water body had a steep gradient for providing access to basking areas/ land.

State of enclosure III before beginning refurbishment work

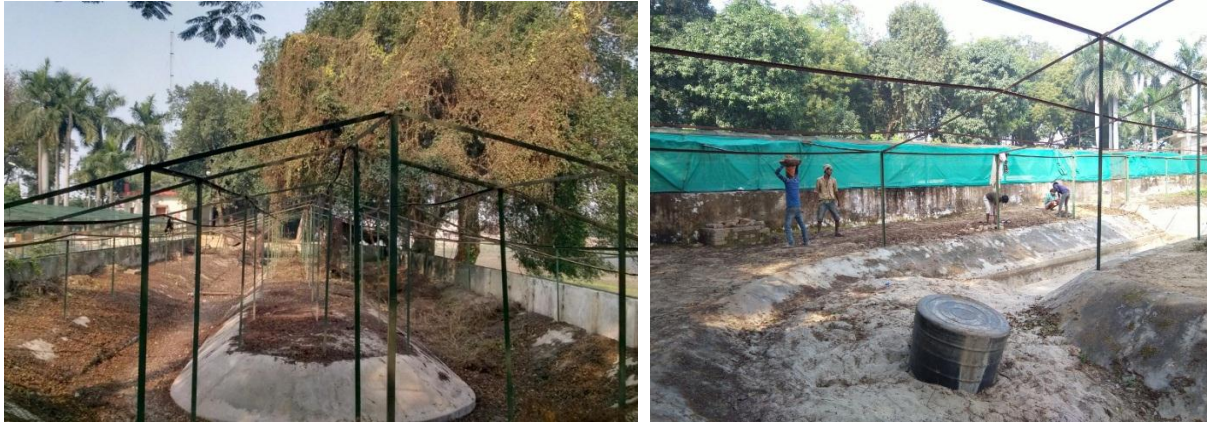
Enclosure III cleared of weeds

Approval for carrying out the required tasks were obtained from authorities concerned and work was initiated. The first task was to clear the area of weeds.

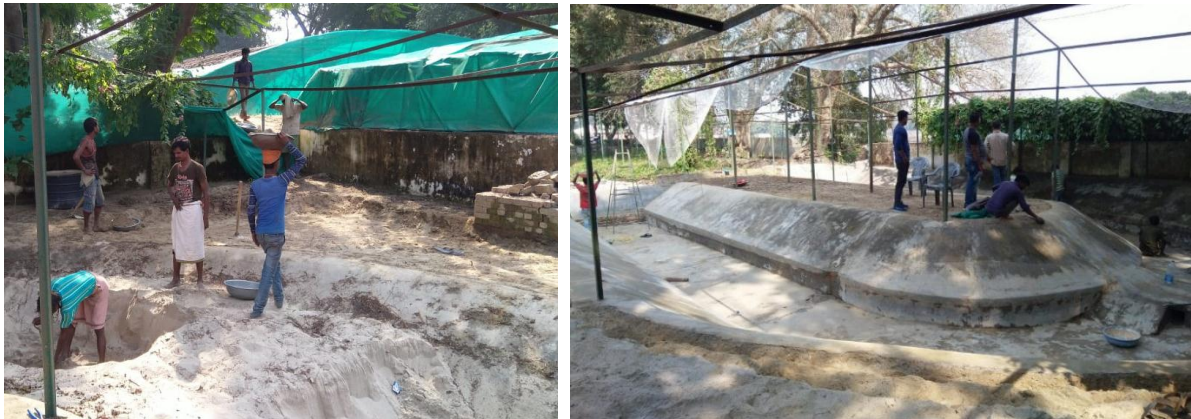
Enclosure III being cleared of sand

Sand removed from the water-body

The task of emptying the water-body of sand was then initiated and carried out over a period of three days.

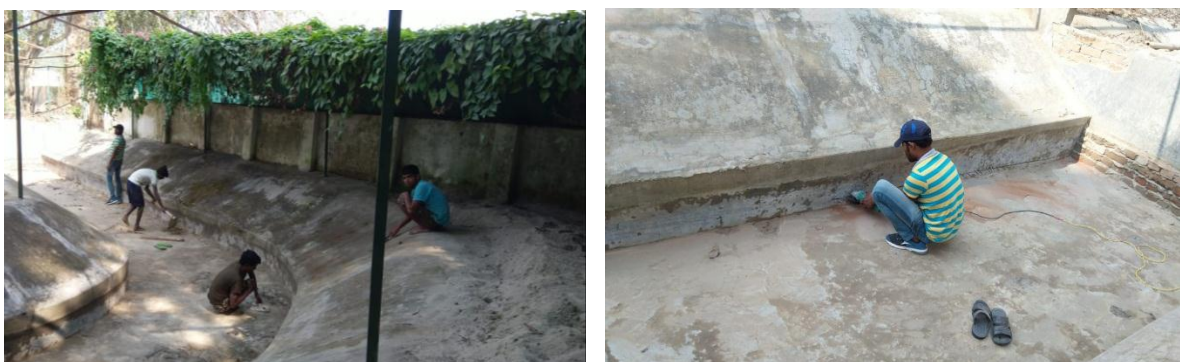
Cleaning of water-body

After clearing the water-body of all weeds and sand it was inspected for cracks by the project team members and the surface scrubbed clean of all moss and debris.

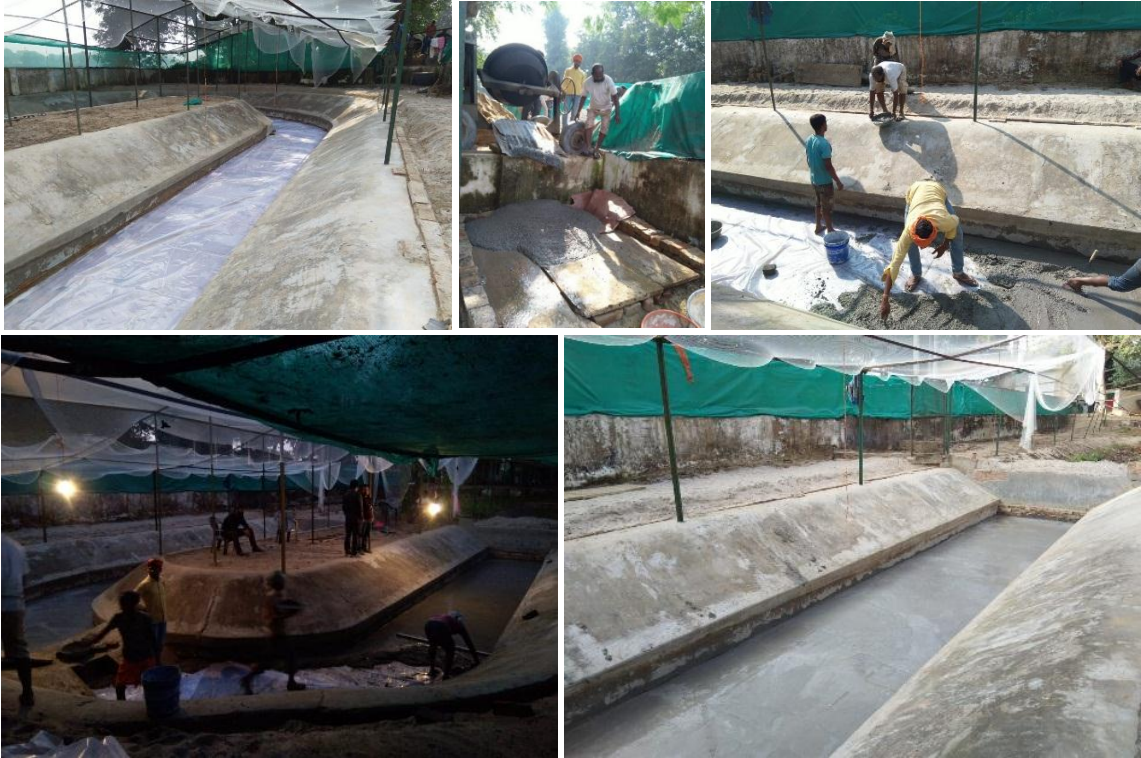
Laying of plastic sheet and concrete mix in the base of the water-body

A plastic sheet was spread across the bottom of the water-body and a three to four-inch-thick layer of concrete was evenly spread over it ensuring proper sealing of all cracks in the sides at the base. Water-proofing material was added to the concrete to ensure proper sealing of all cracks.

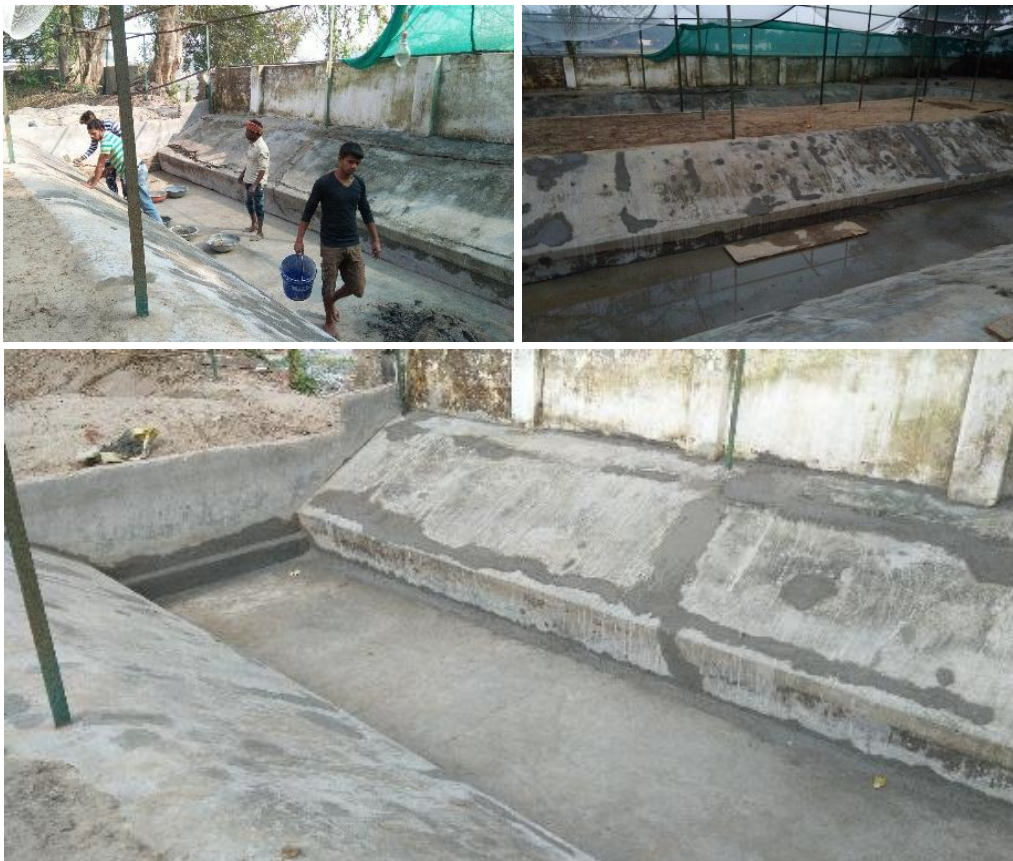
Sealing cracks in the water-body

The concrete base was allowed to set overnight and subsequently all cracks/ damaged portions of the water body were filled with a mixture of cement-mortar and water-proofing mixture to ensure that the water-body retains water.

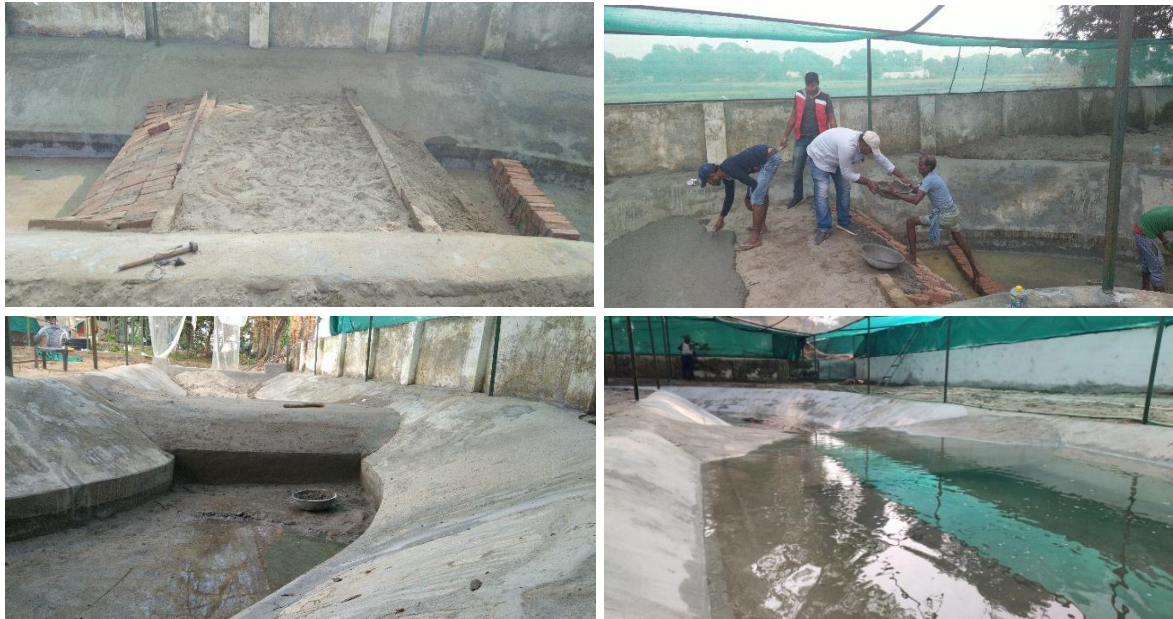
Creation of variable depth gradients in the water-body

Rescued turtles of the same species are usually of are of different ages/ sizes, requiring creation of variable depth gradients for effective use of enclosure space by the animals. It also ensured that the problem of steep gradients on the sides that limits access to basking/ land for smaller turtles could be effectively addressed.

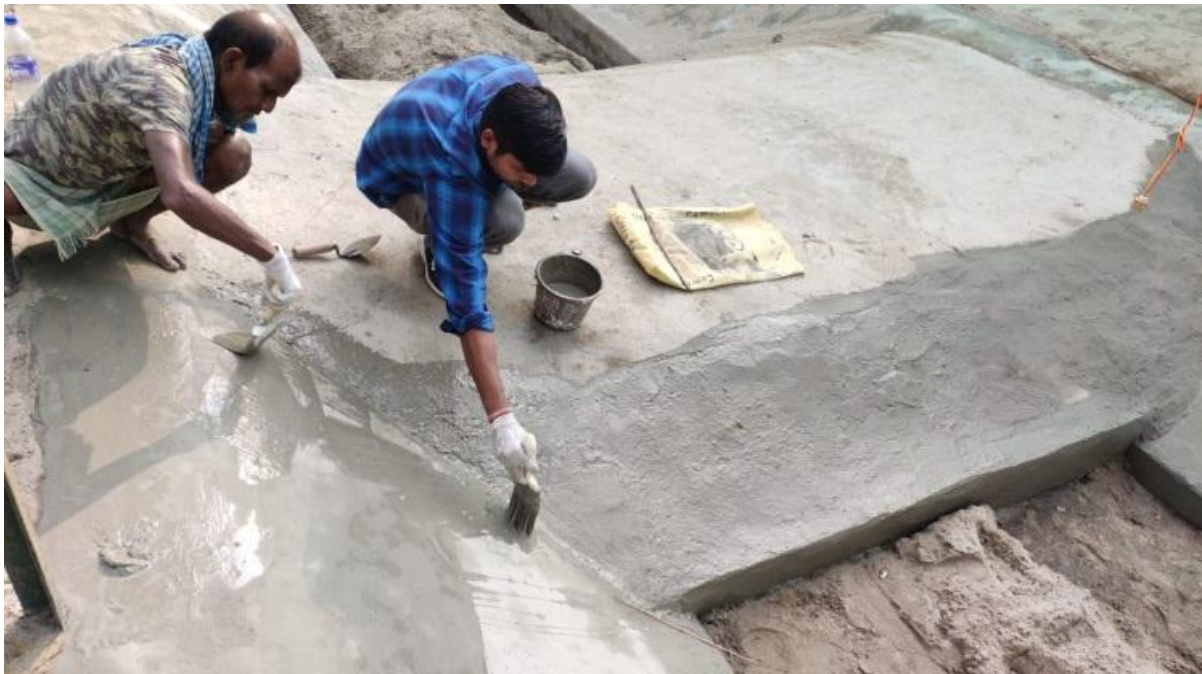
Application of a coating of waterproofing mixture

As a further measure for ensuring that the seepage of water does not recur a double layer of waterproofing compound mixed with cement was overlaid over the entire cemented surface of the water body.

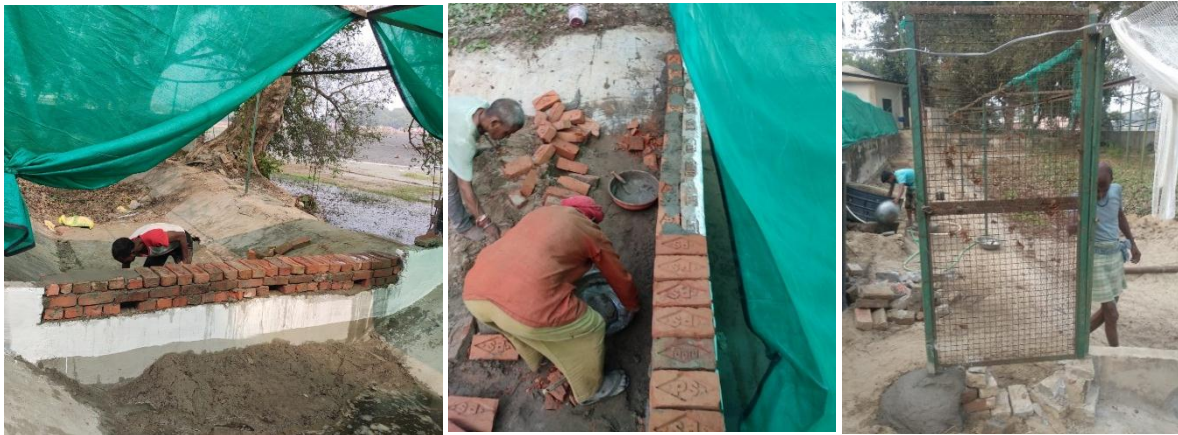
Reinforcing the enclosure partition and installation of gate

A partition was created to bifurcate enclosure III into two halves during 2018; this was further reinforced by adding a layer of bricks and overlaying it with a plaster of cement-mortar on the unused side. A gate was put-up to secure entry to the enclosure.

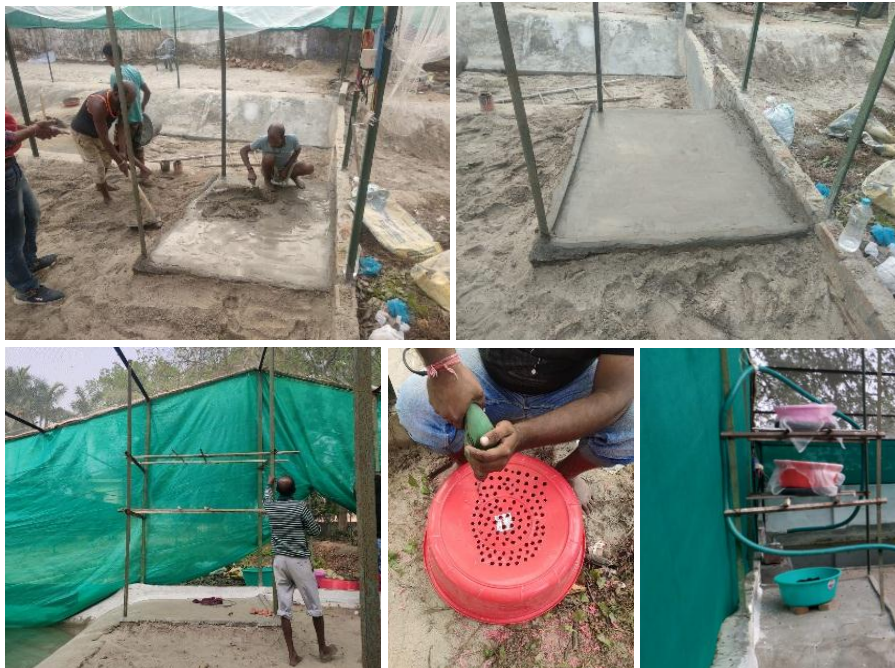
Setting up the filtration unit

The water in captive facilities tends to get fouled with excreta of turtles, left-over food and debris; maintaining water-quality for aquatic animals is however, essential as captive housing facilities with poor water-quality lead to a build-up of pathogens and increase likelihood of animals falling prey to opportunistic infections. Accordingly, a small water filtration unit was set up in the enclosure.

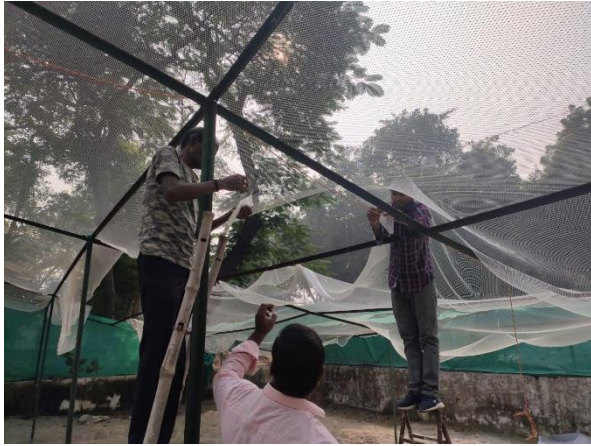
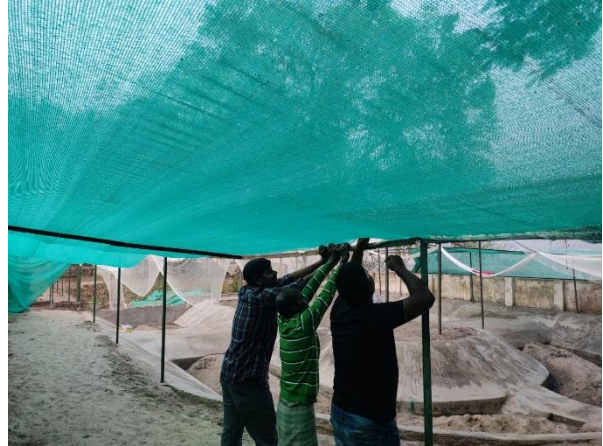
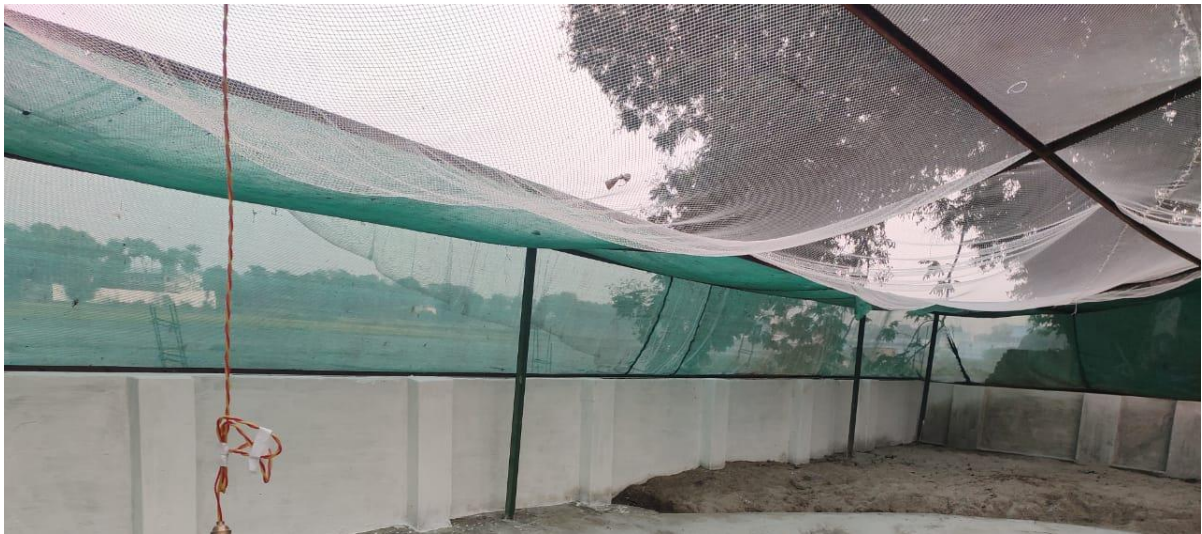
Covering the top of the enclosure

The wire-mesh protecting the enclosure from birds of prey had disintegrated with time and had to be replaced. As a cost effective measure a one-inch mesh size fishing net was spread over the top of the enclosure on the mild steel angle frame already present. The sides of the enclosure were covered with a green-mesh to act as visibility barrier and to provide shade in a part of the enclosure.

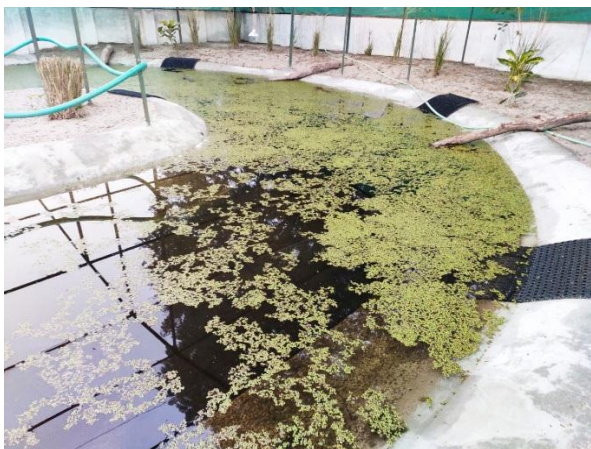
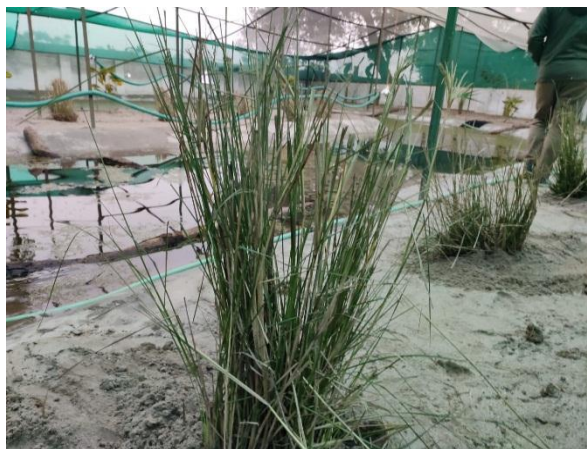
Enclosure after refurbishment

Turtles are ectothermic animals and use sun, shade and water to regulate their body temperature, they also feed on a variety of aquatic vegetation. The enclosure was appropriately planted with plants and grasses to provide a mosaic of sun and shade areas. While the water-body was filled with aquatic vegetation (duckweed: *Lemna sp.*) that occurs naturally in the area.

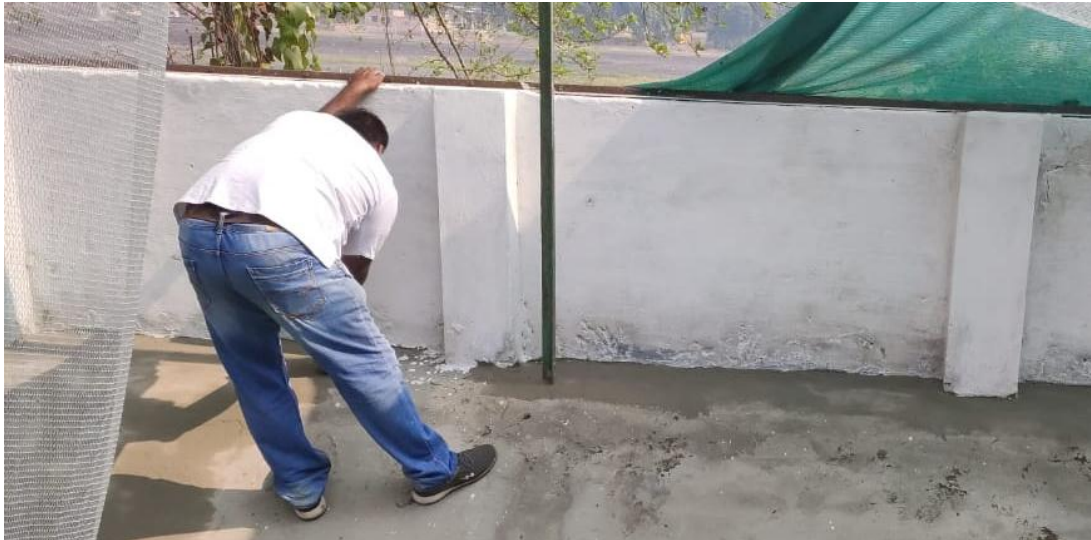
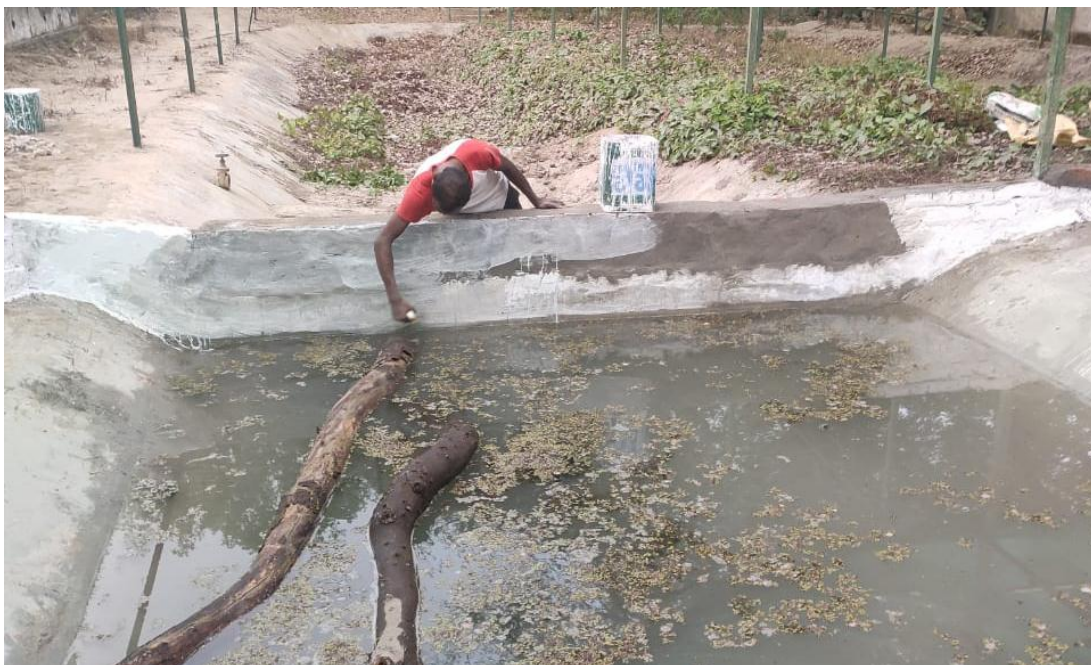
Whitewashing the walls

The walls of the enclosure were whitewashed with lime paint to give an aesthetic look to the enclosure and remove moss growing on the walls.
