Household Sanitation Survey Rishikesh

Identification of current onsite sanitation scenario in Nagar Nigam Area

New Delhi, April 2020

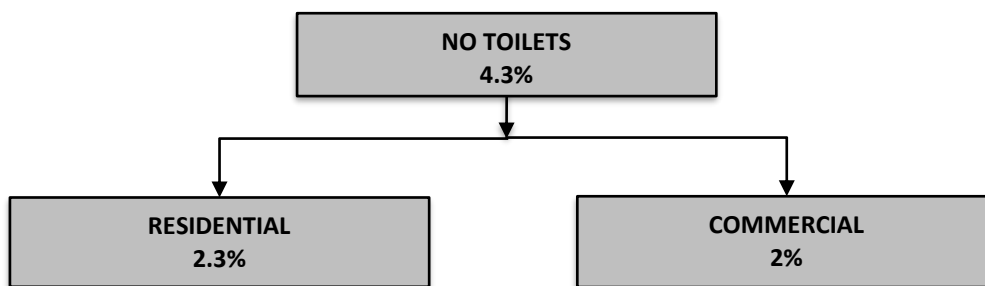
Chart 5.1: Break-up of Residential Properties with No Individual Toilet

Chart 5.1 clearly shows that about a half (47%) of all such properties with no individual toilet facility within their premises also do not have the facility of a community toilet in their close vicinity. The numbers of such properties with no individual toilet facility within the premises and also having no access to community / public toilet was found to be significantly higher in the two wards: Ganga Vihar and Barrage (see Table iv of Annexure-1).

Amongst the properties not having toilets, it was worthwhile to find out how many of them were residential and how many of them were commercial as the commercial properties comprising of small shop normally do not have toilet. It may be observed that out of 542 properties 255 were commercial properties. The result of this segregation is duly presented in chart 5.1 and in **Table iv of Annexure-1**.

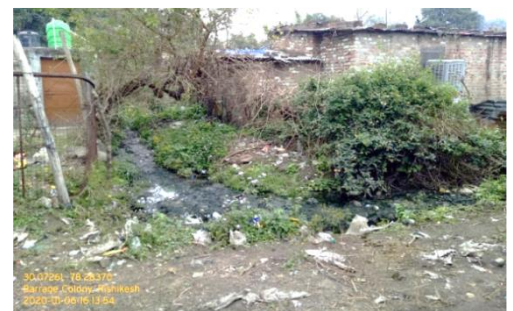
Overall, 268 properties, representing about 3% of the total 9,489 properties relying on on-site sanitation, were found to be discharging black-water directly into open or closed drains. The number of such properties was found to be the highest in Sarvahara Nagar ward (101 Nos.) followed by Bharat Vihar ward (84 Nos.). The geographical locations of such properties have been duly plotted in **Map-xiv** under **Annexure 2**.

Figure 5.2: A Snapshot of Property Discharging

It was revealed that 268 properties (2.8% of total properties) were directly connected to open drains. Incidentally, close to four-fifth (79%) or 213 such properties were found in Ward Nos. 23, 24, 26 and 31. As a matter of fact, Ward No. 23 Sarvahara Nagar (101 properties) and Ward No. 24 Bharat Vihar (84 properties) had the maximum concentration of such properties as shown in **Map xiv of Annexure-2**. All these 213 properties were found to be overlooking an open drain flowing through these wards. Therefore, this issue needs immediate attention of Nagar Nigam authorities.

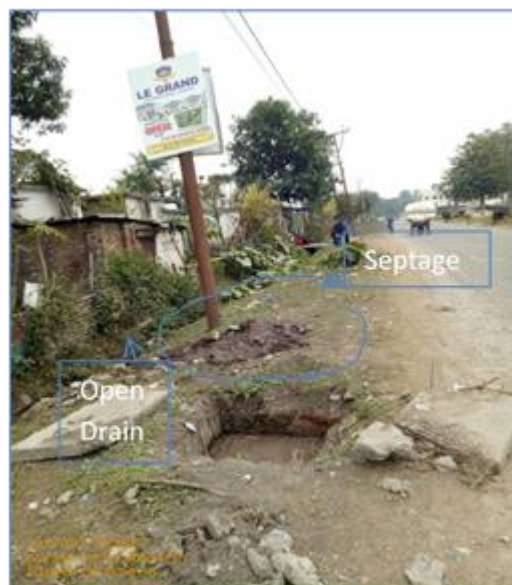
There was a curious case of Barrage Colony, where it was reported that some of the houses instead of septic tank/pit were having 1mX1mX1m chambers in front of their houses. These chambers were connected through closed drains to a large Septic Tank, which was built for the whole colony. On the visit to the big septic tank in the ward, it was found completely dry. The immediate question came forth in front of the senior members of the field survey team that where did the septage from these

chambers go? Subsequently, walking along these chambers it was revealed that these chambers get frequently filled. At times emptied sludge was found right next to the chambers in the open. The greater cause of concern was that some of these households were situated on the bank of river and the sludge emptied from the chambers was kept overlooking the storm water drains, ultimately connected to river. Post a heavy rainfall, the sludge kept outside the chambers gets mixed with rain water and flows through the storm water drains and finally flows into the river. The survey team also informed about an old sewer line at the entrance of the ward. However, the septage was unable to flow through old sewer line mainly because the main sewer line, to which the old sewer line was joined, was on a higher elevation, which resulted in backflow of septage. A suitable pump is immediately required to be installed for transferring the septage from old sewer line to main sewer line besides cleaning the blockages in the old sewer line.
