REPORT ON CENSUS SURVEY OF WATER BODIES

BIHAR

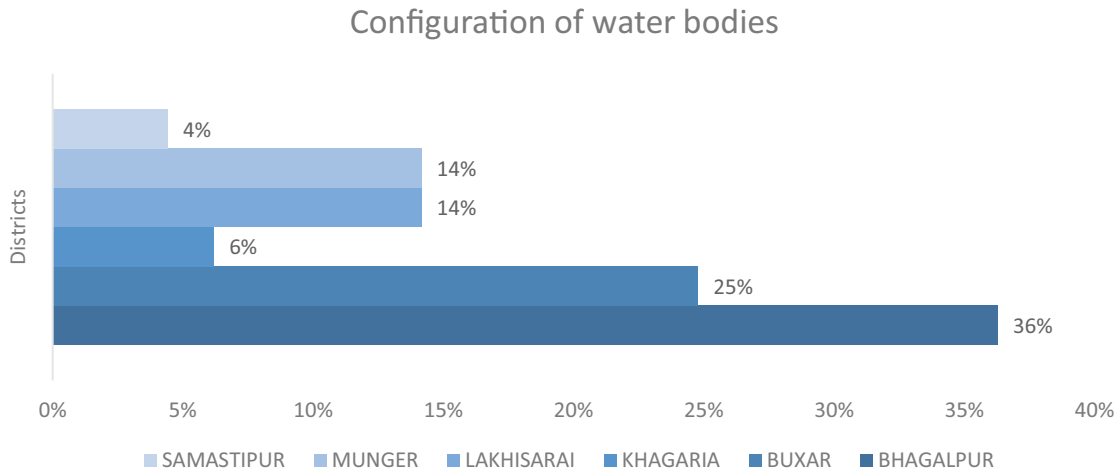
Figure 4.1: District-wise configuration of water bodies

District-wise percentage distribution of water bodies is shown in the graph below:

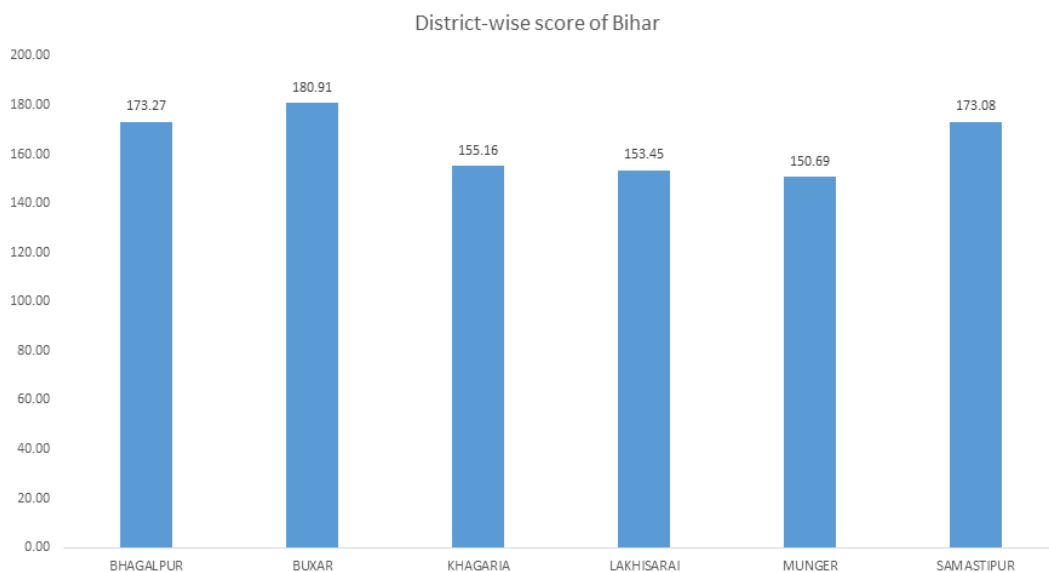
Figure 4.2: District-wise scores of Bihar

Scores have been summarized on the basis of all the seven indicators mentioned in scoring methodology, which were considered as the key factors for evaluation of the water bodies. As per the evaluation, Bihar stands with an average score of 164.43 out of 300.

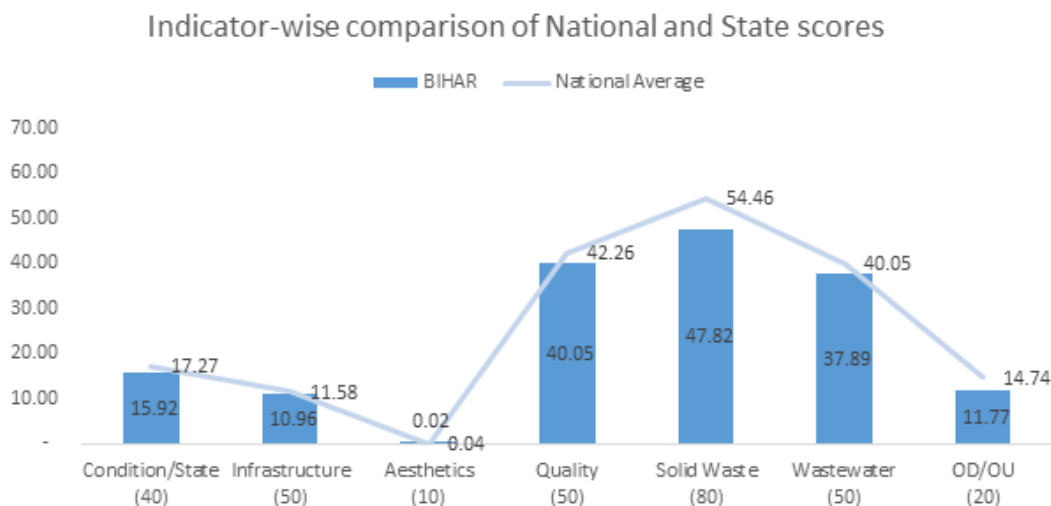
Figure 4.3: Indicator-wise comparison of National and State scores

The figure given below represents indicator-wise comparison of the State average and National average scores. Evaluation of scores and grades was done on the basis of seven key indicators mentioned in the graph below:

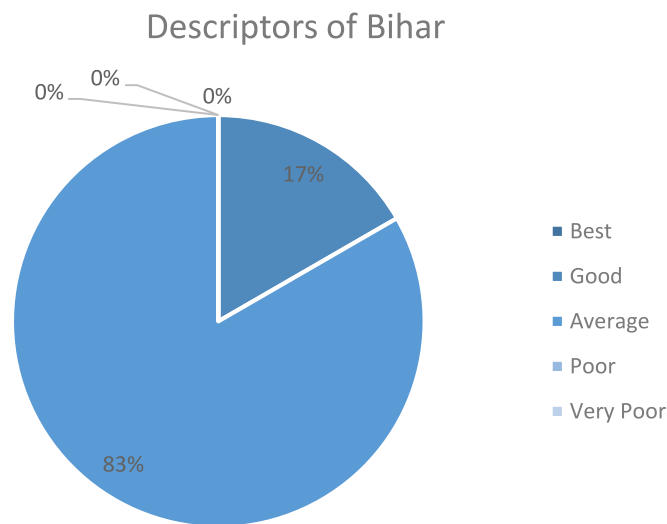
Figure 4.4: Performance based descriptors of Bihar

Water bodies found in various districts of Bihar were lying under different descriptors as per their performances. These descriptors are characterized by seven indicators for evaluation of water bodies, which denotes 'Water body Cleanliness Index'.

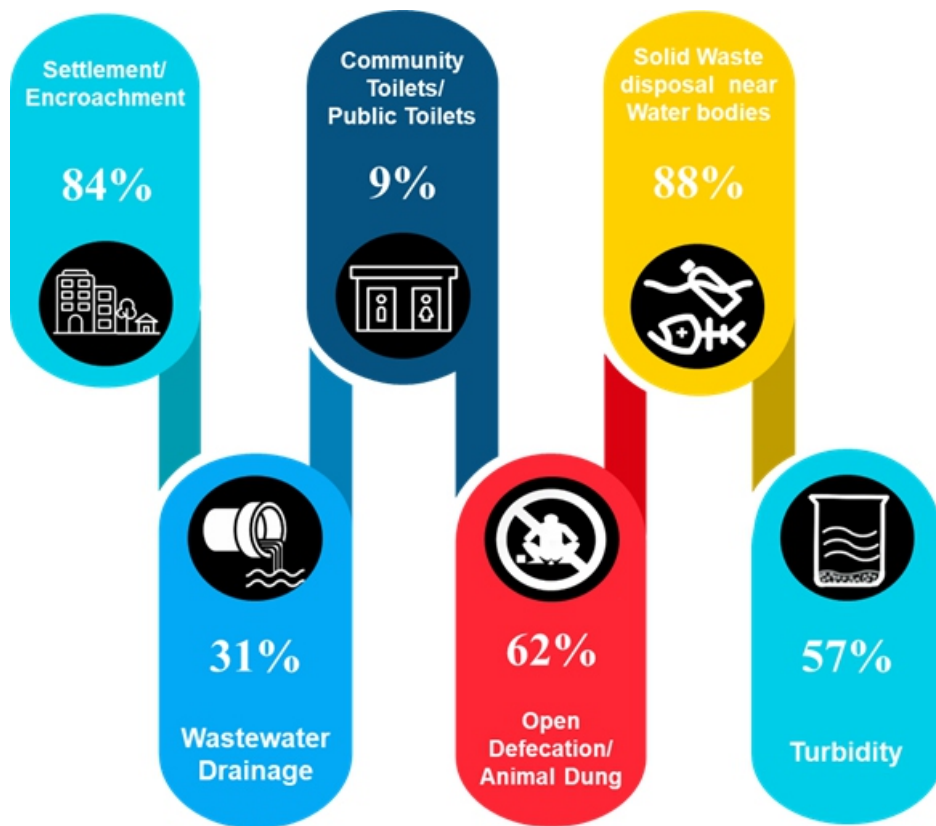
Figure 4.5: Key finding of water bodies found in Bihar

113 water bodies were found in 67 Ganga villages during the survey. The percentage figures highlight that how many water bodies had the presence of below-mentioned parameters out of the total water bodies surveyed. These figures may be attributed to the performance of a water body in the 'Water Body Cleanliness Index'.

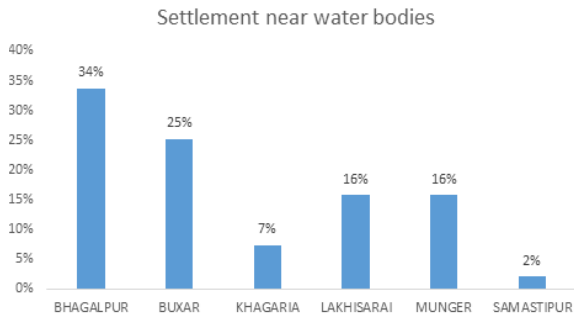
Figure 4.8: Settlement near water bodies (District-wise)

b. Figure mentioned below is with respect to the percentage distribution of Settlement found near 95 water bodies across 6 districts:

- Highest percentage of settlements was found near water bodies present in Bhagalpur district with 34 per cent.
 - Lowest percentage of Settlements was found near water bodies present in Samastipur with 2 per cent.
- c. The figure mentioned below is with respect to the 'Percentage distribution of Type of Settlements' found near 95 water bodies across 6 districts:

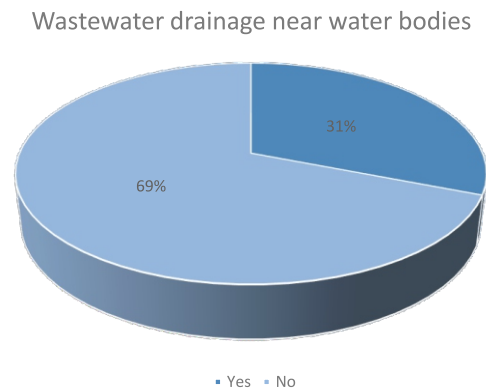
Figure 4.10: Wastewater drainage near water bodies

- a. Figure mentioned below is with respect to the 'Wastewater drainage' found out of 113 water bodies assessed during the survey:

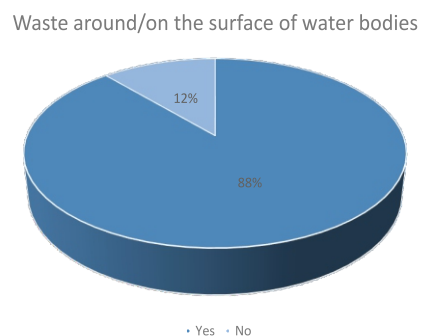
Figure 4.13: Waste around/on the surface of water bodies

a. Figure mentioned below is with respect to the Solid Waste present around/on the surface out of 113 water bodies assessed during the survey:

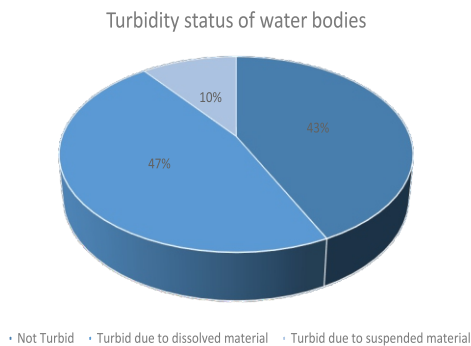
Figure 4.19: Turbidity status of water bodies

Figure mentioned below is with respect to 'Turbidity (Beaker test)' of water present in 77 water bodies during assessment:

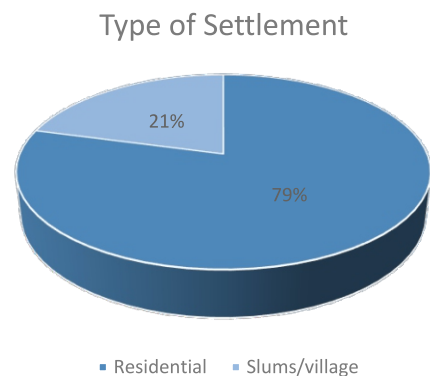
Figure 4.25: Type of Settlement around water bodies in Buxar

Figure 4.25 configures two types of settlement, which denotes that Slums/village has 21 per cent occupancy and 79 per cent of the water bodies were surrounded by Residential households.

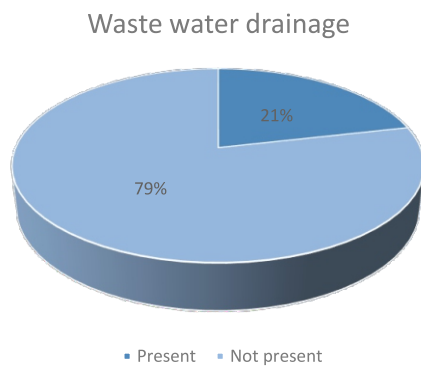
Figure 4.26: Wastewater drainage in and around water bodies in Buxar

Pie-chart, 4.26 represents Wastewater drainage present near water bodies assessed in Buxar where 21 per cent of the water bodies get contaminated through wastewater drainage as a cause of direct run-off.

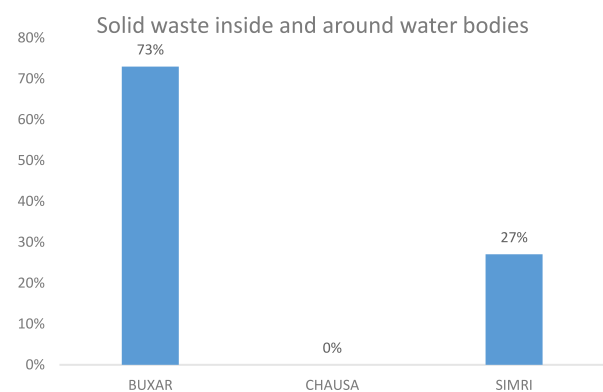
Figure 4.27: Solid waste inside and around water body in Buxar

- Buxar block accounts for the highest total as 73 per cent of the water bodies had solid waste present in/around them.
- No solid waste present in/around the water body found in Chausa.
- Simri accounts for 27 per cent of water bodies having solid waste present in/around them.
