REPORT ON CENSUS SURVEY OF WATER BODIES

JHARKHAND

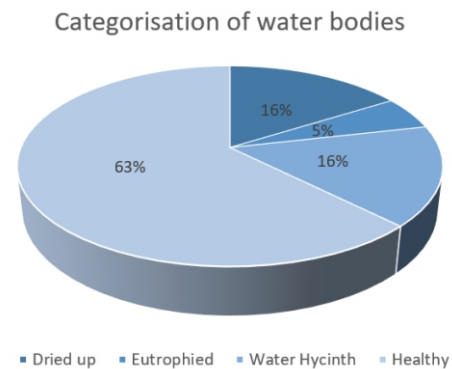
Figure 4.4: Categorization of water bodies

In Jharkhand, 63 per cent of the water bodies were found to be healthy and 16 per cent had Water hyacinth present in them. The study also found that, these water bodies had socio-economic benefits attached with them. For example: Domestic usage, Irrigation purposes, drinking water for cattle and pisciculture.

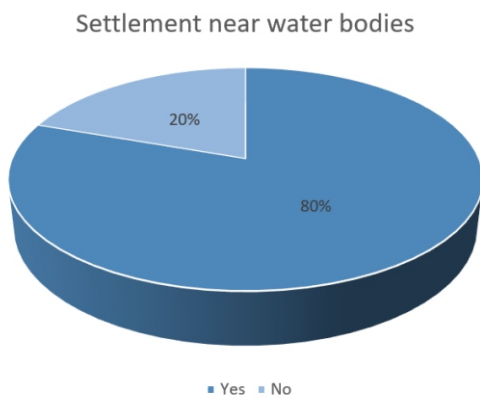
Figure 4.5: Settlement near water bodies

Settlements were found near 80 per cent of the total water bodies which can become a major reason for its contamination. Moreover, cases of illegal possession of land around the water bodies were found according to the citizen feedbacks.

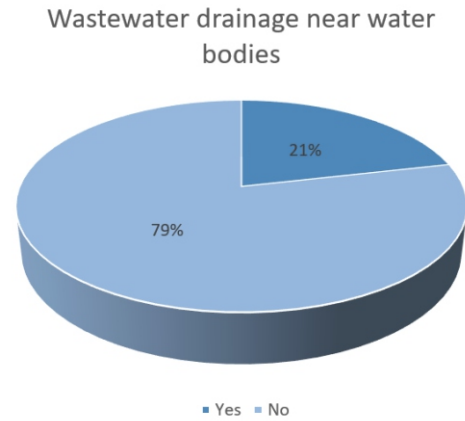
Figure 4.8: Wastewater drainage near water bodies

About 21 per cent of the total water bodies found in Jharkhand were found having Wastewater drainage on its edge/nearby or connected in a way that it inflicted them primarily. Drainage run-off directly into the water bodies turned out to be one of the major factors for Algal blooms and Low oxygen saturation levels present in it.

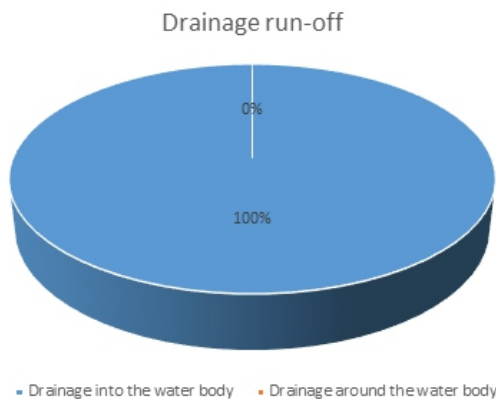
Figure 4.10: Drainage

100 per cent of the drainage directly flow into the water bodies. This study states that flow of Storm-water drainage directly into the water bodies replenished them. On the other hand, flow of wastewater drainage directly into the water bodies is harmful for its health. Moreover, it was observed that Secondary treatment plant or Filtration mechanism were not found near water bodies.

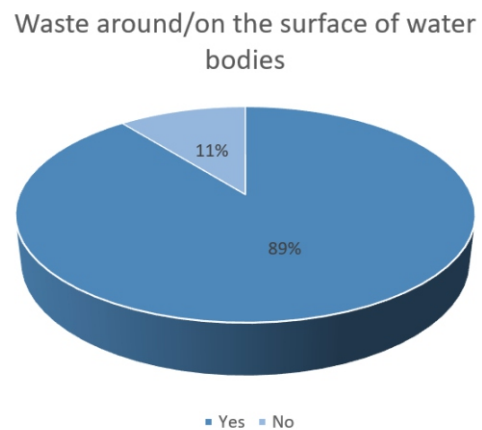
Figure 4.11: Waste around/on the surface of water bodies

Out of 56, 50 water bodies had solid waste present around/on its surface. Furthermore, it was found that, there were no methods of Fine mechanisms or Anti-littering signage near public water bodies to discourage such unhealthy activities.

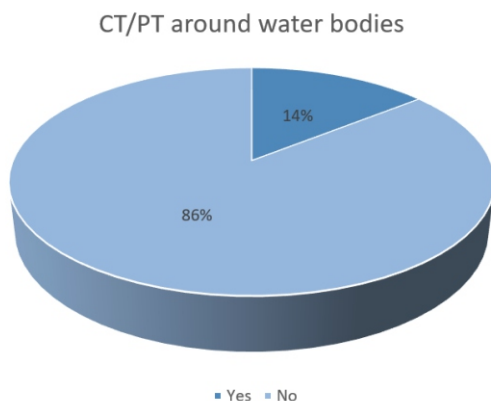
Figure 4.13: CT/PT around water bodies

Community/Public toilets found near the water bodies in Jharkhand were not in a condition to be called proper or usable. In the name of toilets, small cubicles were found during the assessment, which constitutes only five per cent of the total water bodies.

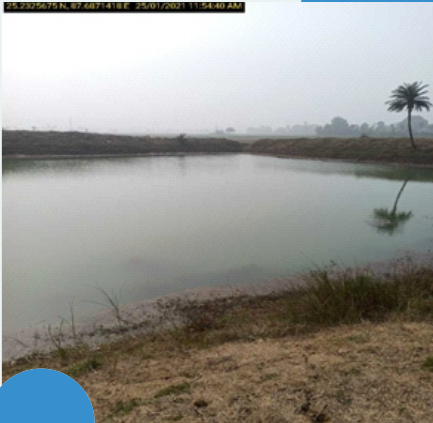
Healthy | JH_SATI CHAUKI PANGRO
358494_013231_W1

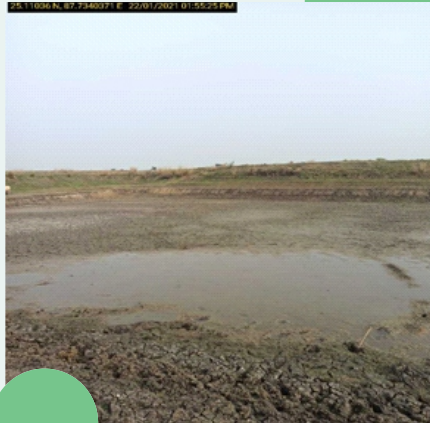
Dried up | JH_MOKIM PUR
Tmp512959_028266_W6

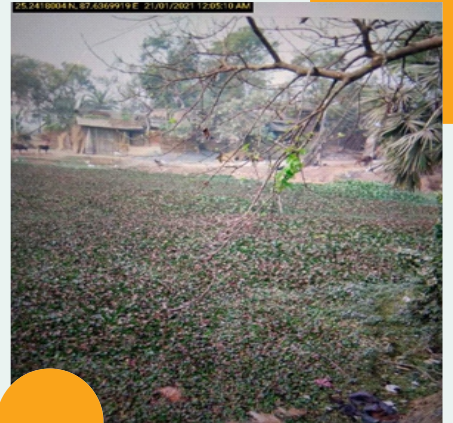
Water Hyacinth
JH_FATAH PUR_359601_013521_W1

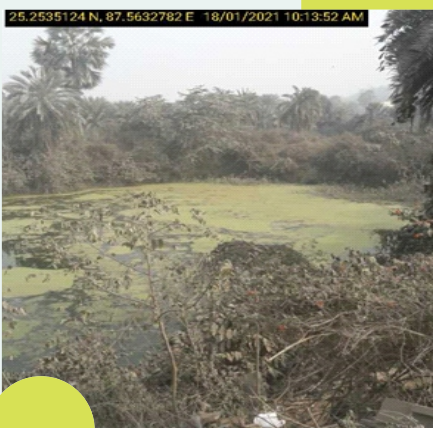
Eutrophied | JH_MANJHI KOLA
357938_013371_W1

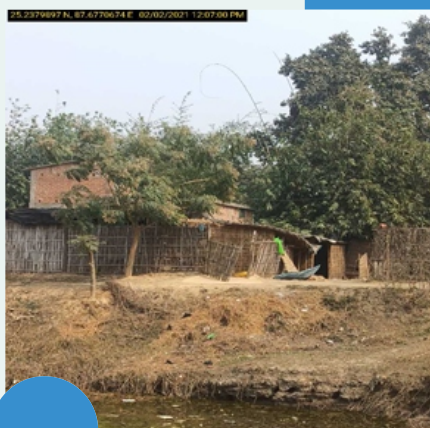
Encroachment | JH_SATICHAUKO
KHUTAHARI_358500_013201

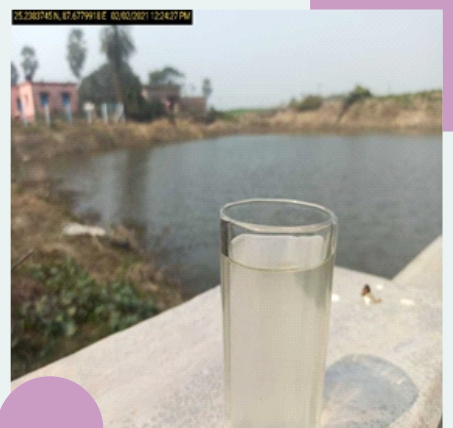
Turbid due to dissolved materials
JH_CHHOTA PANGRO_358499_013191_W1

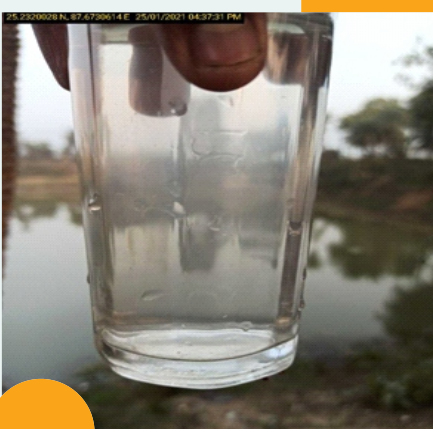
Not Turbid
JH_BARA TOUFIR_358495_013211_W1

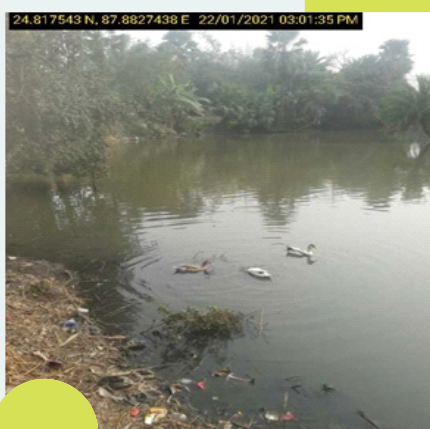
Waste Inside
JH_MISNAL PUR_Tmp512958_028241

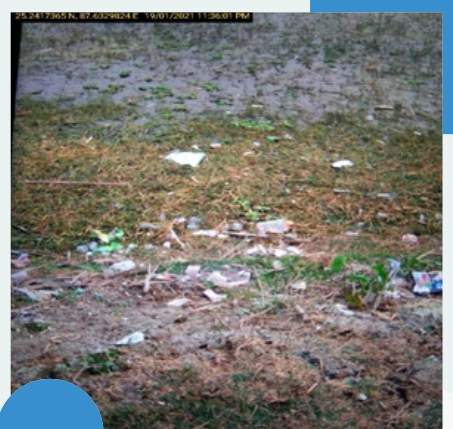
Waste around
JH_MASKALAIYA_358833_013532_W2

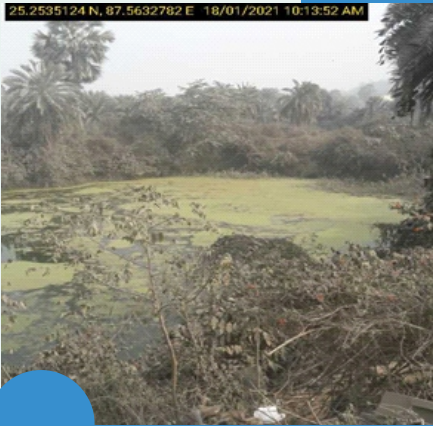
Thick layer of algal bloom
JH_MANJHI KOLA_357938_013371_W1

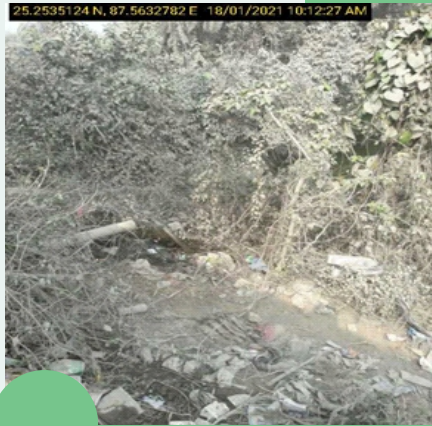
Drainage present
JH_MANJHI KOLA_357938_013371_W1

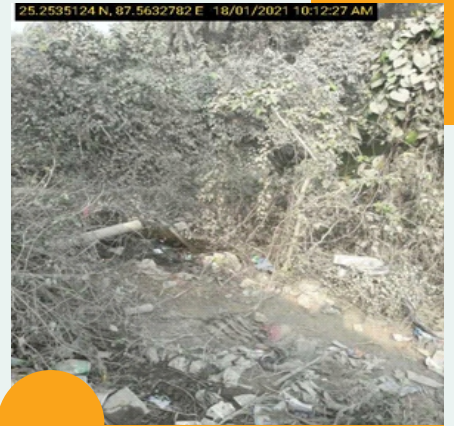
Open defecation
JH_PAHARPUR_348238_013156_W6

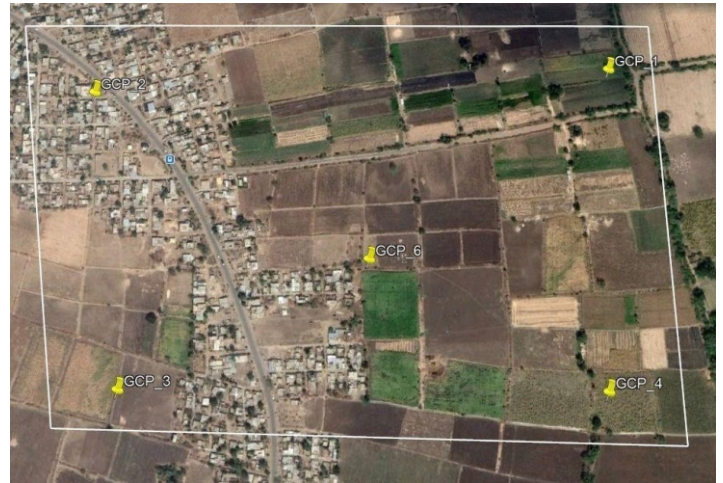
Planning involves fixing AOI, placing GCP's across the AOI, and fixing the flight parameters such as Ground Sampling Distance (GSD) or spatial resolution, Frontal overlap, Side overlaps according to project requirements.

Figure: Drone AOI with GCP placement

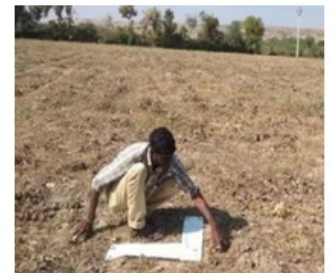
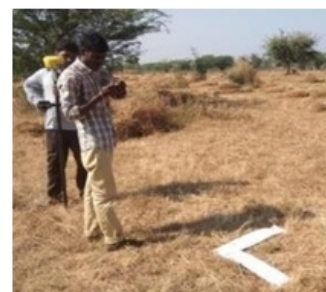
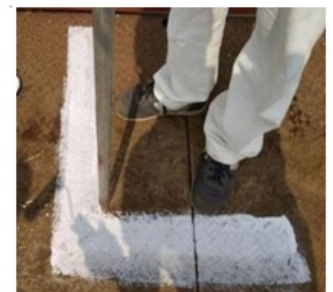
Check Points (CP) are markers laid on the ground which will be incorporated in the photogrammetry processing to improve the accuracy of the dataset. Distance between them is obtained with traditional surveying methods in the field. CPs are necessary for orientation and placement of aerial photographs in the spatial coordinate system.

Figure: Sample GCP, placement on ground and taking reading on it

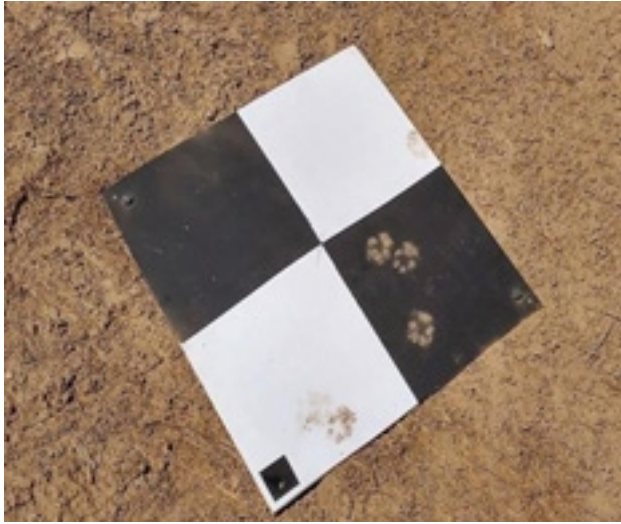
Data Collection involves preliminary reconnaissance survey around the AOI for placing GCP's. Once the GCP's were placed DGPS survey will be conducted to observe the placed GCP's.

Figure: GCP Banner from Field Survey

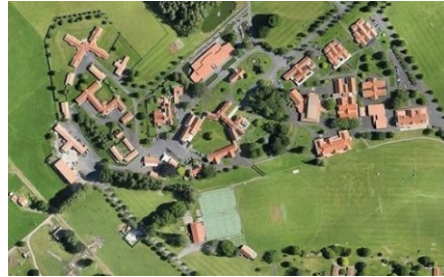
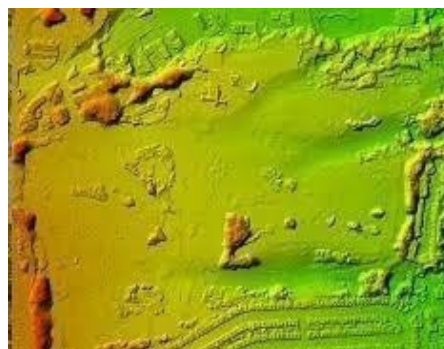
generated. The resolution of outputs depend on the GSD which further decreased to higher resolution using GIS software.

Figure: Ortho and DSM processed from software

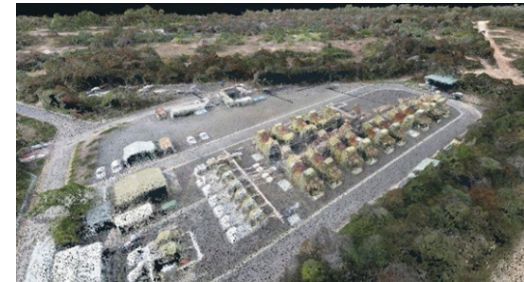
density of 30-50 points per sq.m. Point cloud density can be varied based on the GSD and processing setup.

Figure: Point Cloud processed from Images

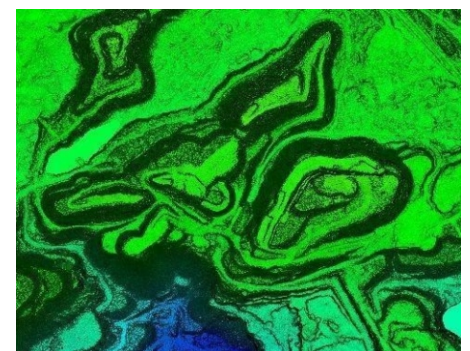
Point clouds, Orthomosaic can be further processed to extract digitised boundary layers, contours, Digital Terrain Model etc.

Figure: DTM cleaned and extracted from Point cloud
