REPORT ON CENSUS SURVEY OF WATER BODIES

UTTAR PRADESH

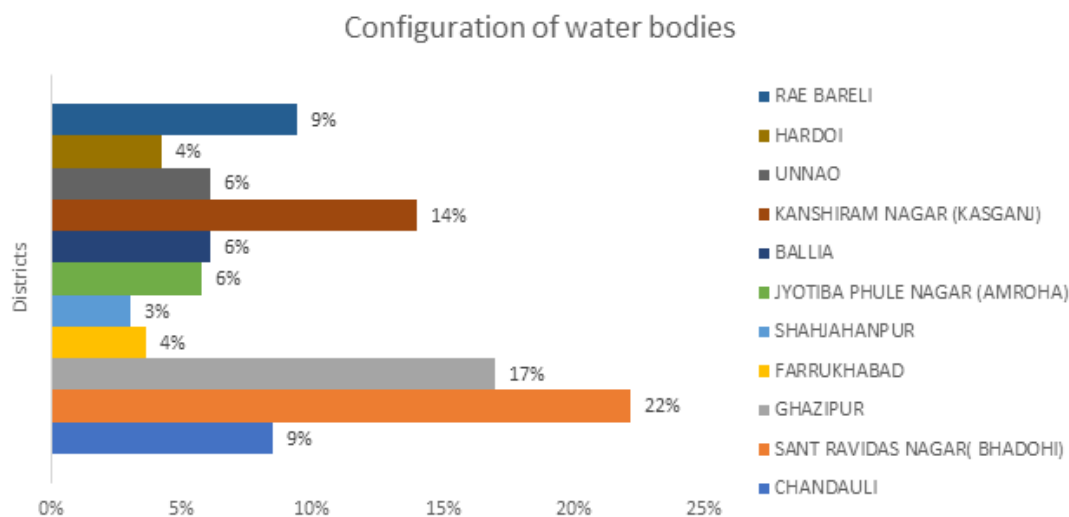
Figure 4.1: District-wise configuration of water bodies

District-wise percentage distribution of water bodies is shown in the graph below:

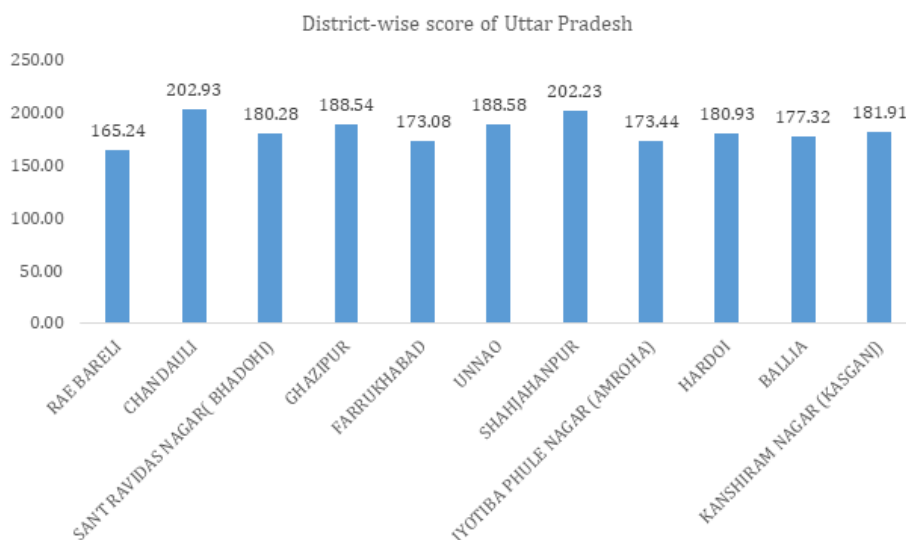
Figure 4.2: District-wise scores of Uttar Pradesh

Scores have been summarized on the basis of all the seven indicators mentioned in scoring methodology, which were considered as the key factors for evaluation of the water bodies. As per the evaluation, Uttar Pradesh stands with an average score of 183.13 out of 300.

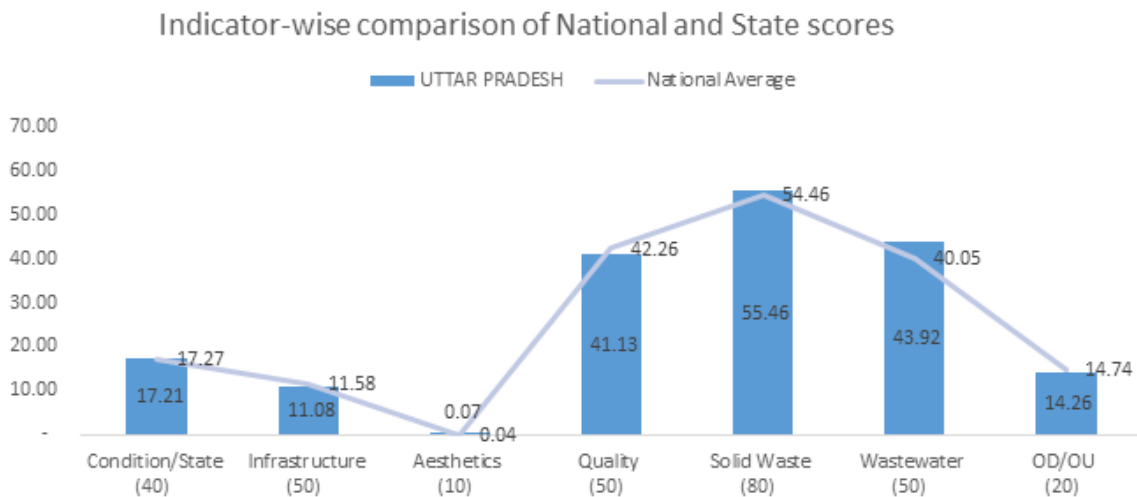
Figure 4.3: Indicator-wise comparison of National and State scores

The figure given below represents indicator-wise comparison of the State average and National average scores. Evaluation of scores and grades was done on the basis of seven key indicators mentioned in the graph below:

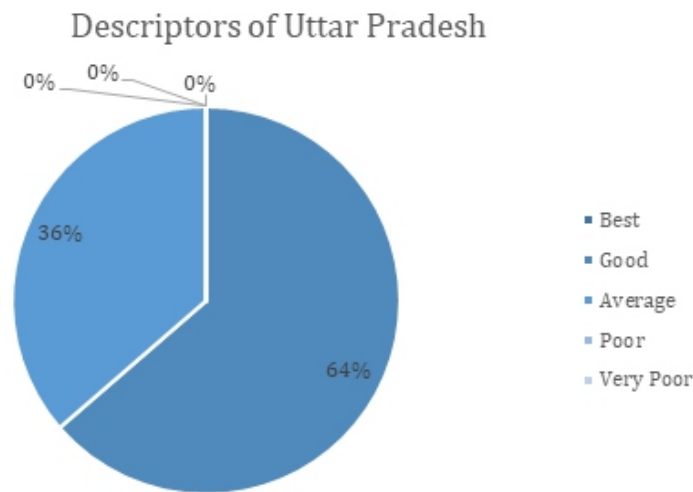
Figure 4.4: Performance based descriptors of Uttar Pradesh

Water bodies found in various districts of Uttar Pradesh were lying under different descriptors as per their performances. These descriptors are characterized by seven indicators for evaluation of water bodies, which denotes 'Water body Cleanliness Index'.

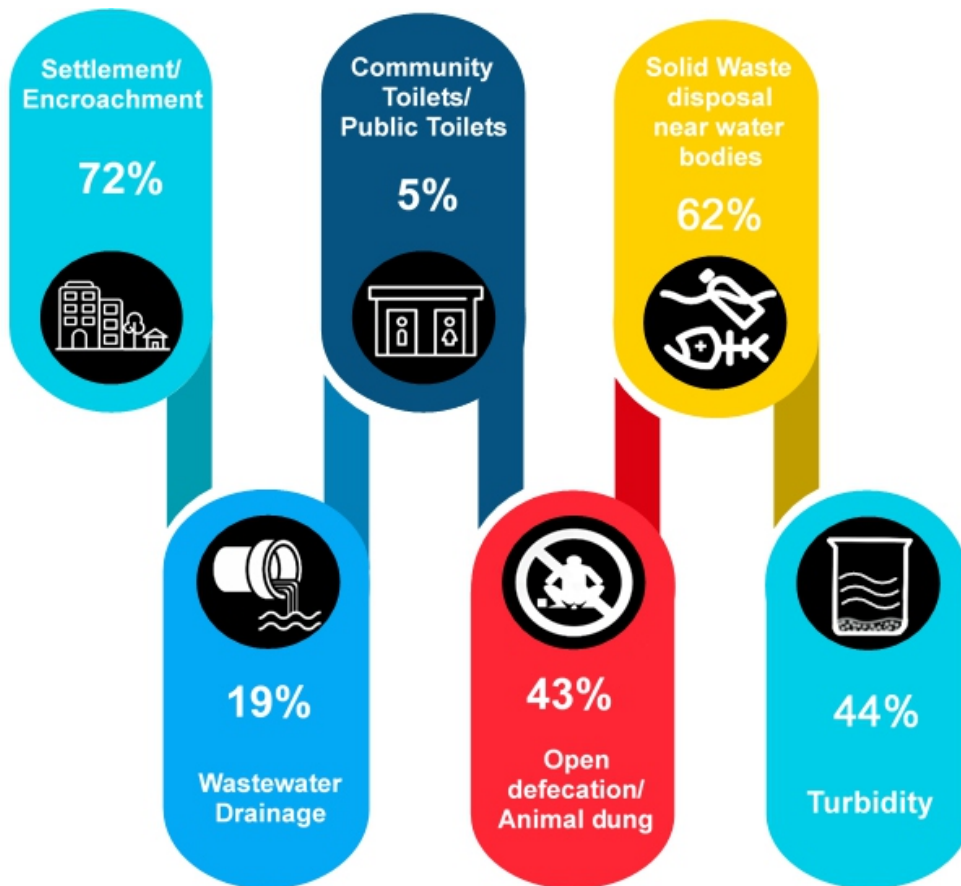
Figure 4.5: Key finding of water bodies found in Uttar Pradesh

total of 329 water bodies were found in 245 Ganga villages during the survey. The percentage figures highlight that how many water bodies had the presence of below-mentioned parameters out of the total water bodies surveyed. These figures may be attributed to the performance of a water body in the 'Water Body Cleanliness Index'.

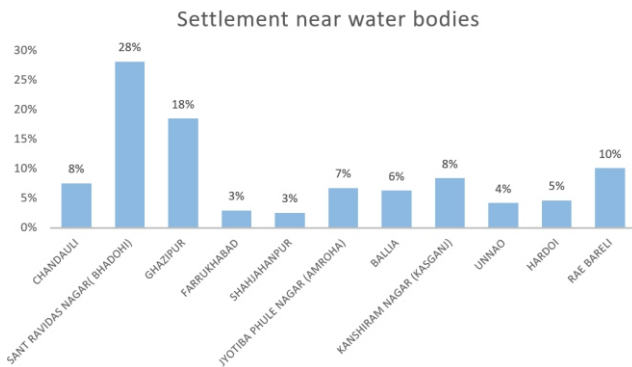
Figure 4.8: Settlement near water bodies (District-wise)

- b. Figure mentioned below is with respect to the percentage distribution of Settlement found near 238 water bodies across 11 districts:

- Highest percentage of settlements was found near water bodies present in Sant Ravidas Nagar (Bhadohi) district with 28 per cent.
- Lowest percentage of Settlements was found near water bodies present in Districts: Shahjahanpur and Farrukhabad with 3 per cent each.
- c. The figure mentioned below is with respect to the 'Percentage distribution of Type of Settlements' found near 238 water bodies across 11 districts:

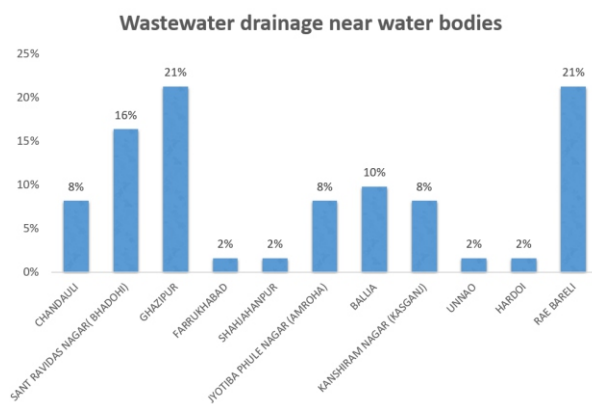
Figure 4.11: Wastewater drainage near water bodies (District-wise)

b. Figure mentioned below is with respect to the percentage distribution of Wastewater drainage found near 61 water bodies across 11 districts:

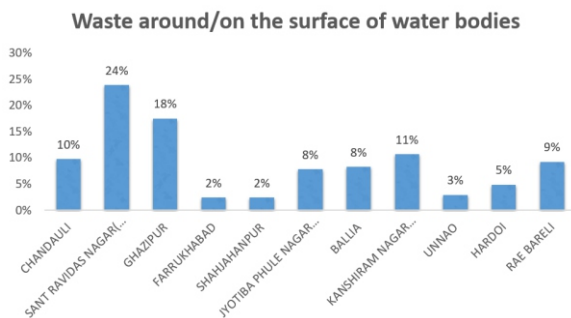
Figure 4.14: Waste around/on the surface of water bodies (District-wise)

b. Figure mentioned below is with respect to the percentage distribution of Solid waste found around/on the surface of 205 water bodies across 11 districts:

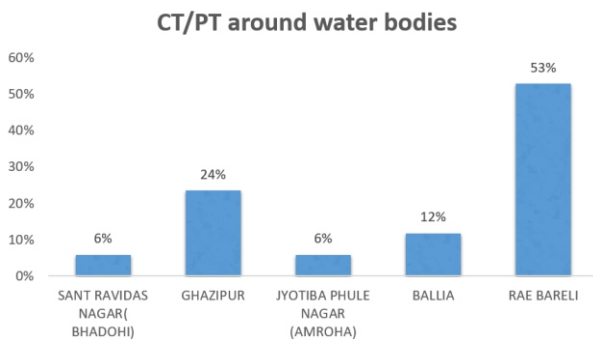
Figure 4.16: CT/PT around water bodies (District-wise)

b. Figure mentioned below is with respect to the 'Percentage distribution of Community/ Public toilet' found near 17 water bodies across 11 districts:

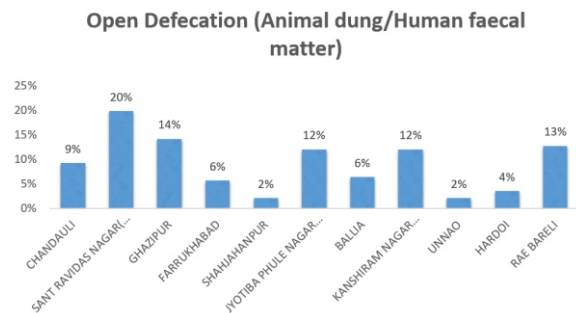
Figure 4.18: Open Defecation: Animal dung/Human faecal matter (District-wise)

b. Figure mentioned below is with respect to the percentage distribution of Open Defecation' found near 141 water bodies across 11 districts:

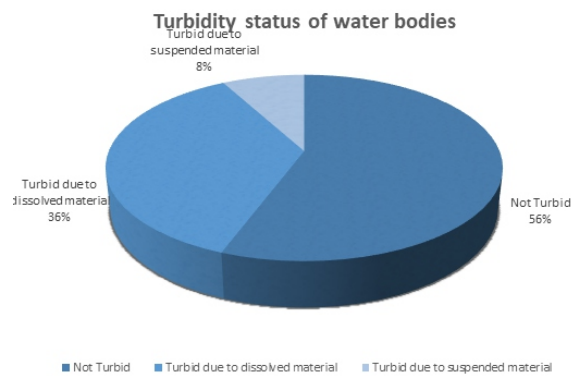
Figure 4.19: Turbidity status of water bodies

Figure 4.19 mentioned below is with respect to 'Turbidity (Beaker test)' of water present in 201 water bodies during assessment:

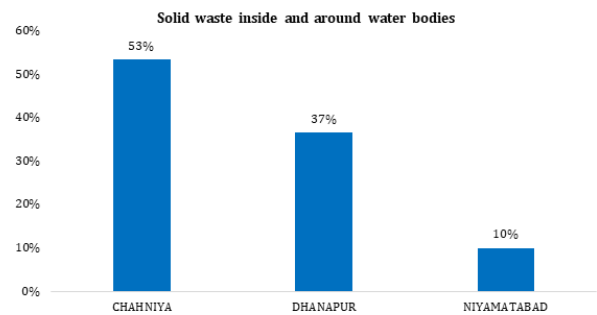
Figure 4.27: Solid waste inside and around water body in Chandauli

- Chahniya accounts for the highest total as 53 per cent of the water bodies had solid waste present in/around them
- Whereas, Dhanapur and Niyamatabad accounts for 37 per cent and 10 per cent of the water bodies having solid waste in/around them

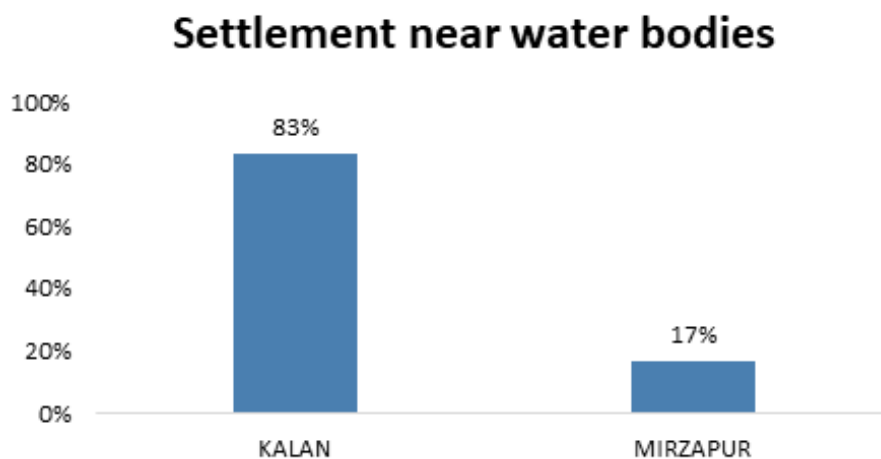
Figure 4.34: Settlement near water bodies in Shahjahanpur

Figure 4.34 depicts block-wise 'Percentage distribution of Settlement' found in Shahjahanpur district. 100% accountability has been captured under 2 blocks with a total count of 6 Water bodies, having settlement present within 200-250 meters of its radius.

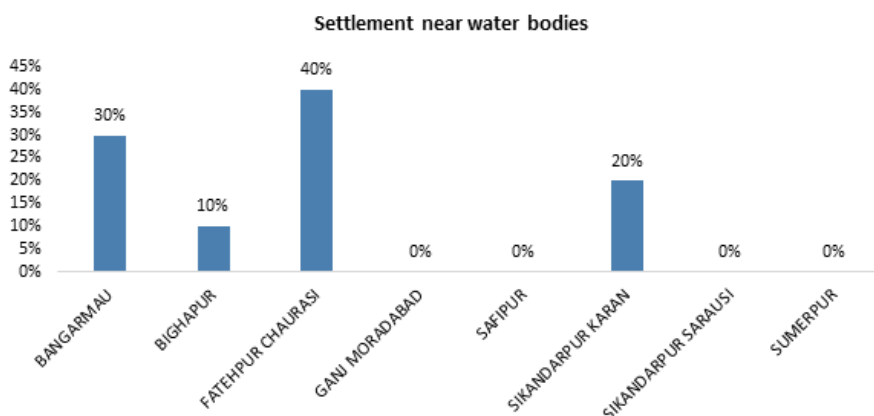
Figure 4.44: Settlement near water bodies in Unnao

No settlement was available near water bodies, which were found in Blocks: Ganj Moradabad, Safipur, Sikandarapur Karan and Sumerpur.

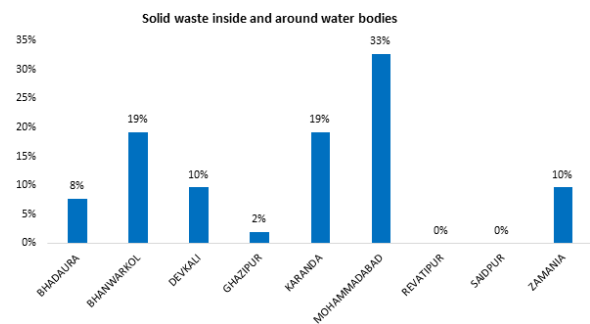
Figure 4.57: Solid waste inside and around water body in Ghazipur

- Mohammadabad accounts for the highest total as 33 per cent of the water bodies had solid waste present in/around them.
- No solid waste present in/around the water bodies found in Revatipur.
- Ghazipur accounts 2 per cent of water bodies having solid waste present in/around them.
