REPORT ON CENSUS SURVEY OF WATER BODIES

WEST BENGAL

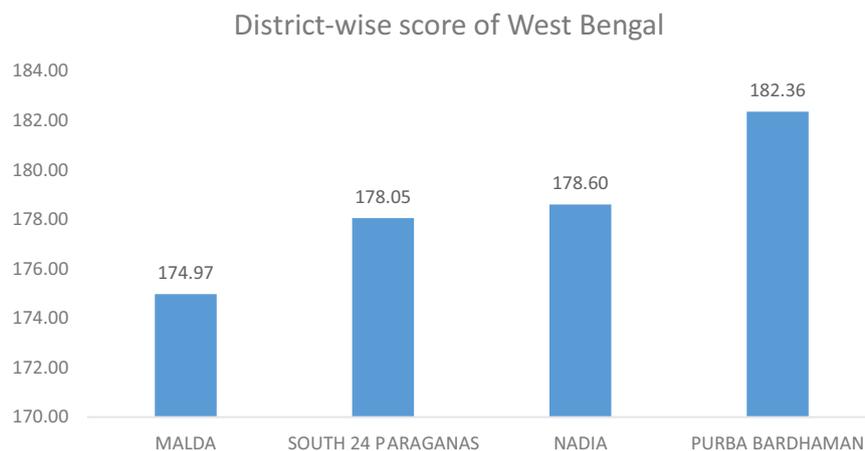
Figure 4.2: District-wise scores of West Bengal

Scores have been summarized on the basis of all the seven indicators mentioned in scoring methodology, which were considered as the key factors for evaluation of the water bodies. As per the evaluation, West Bengal stands with an average score of 178.5 out of 300.

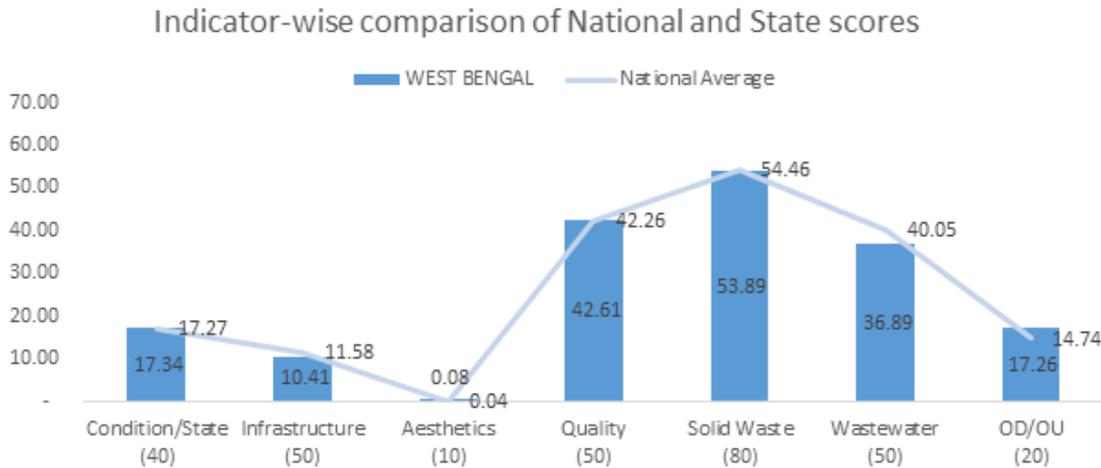
Figure 4.3: Indicator-wise comparison of National and State scores

The figure given below represents indicator-wise comparison of the State average and National average scores. Evaluation of scores and grades was done on the basis of seven key indicators mentioned in the graph below:

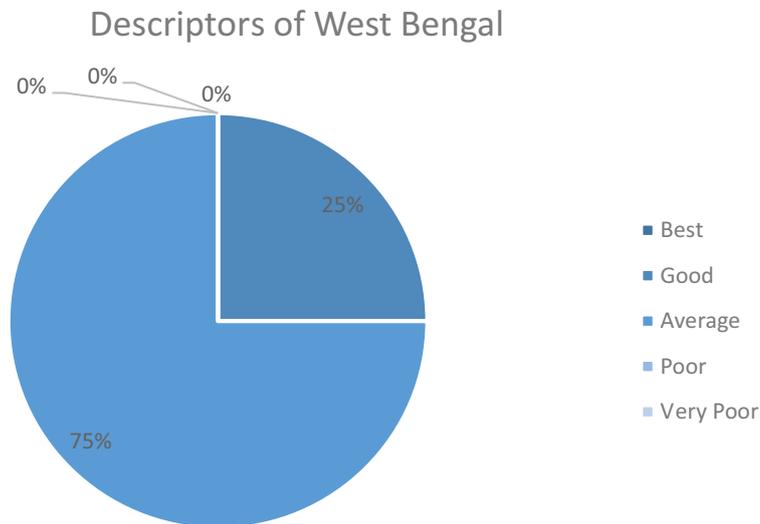
Figure 4.4: Performance based descriptors of West Bengal

Water bodies found in various districts of West Bengal were lying under different descriptors as per their performances. These descriptors are characterized by seven indicators for evaluation of water bodies, which denotes 'Water body Cleanliness Index'.

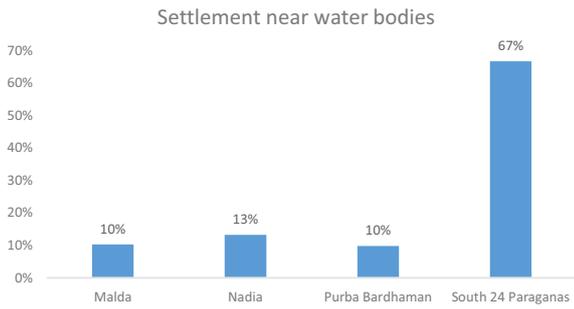
Figure 4.8: Settlement near water bodies (District-wise)

b. Figure mentioned below is with respect to the percentage distribution of Settlement found near 438 water bodies across 4 districts:

- Highest percentage of settlements was found near water bodies present in South 24 Paraganas district with 67 per cent.
 - Lowest percentage of Settlements was found near water bodies present in Districts: Malda and Purba Bardhaman with 10 per cent each.
- c. The figure mentioned below is with respect to the 'Percentage distribution of Type of Settlements' found near 438 water bodies across 4 districts:

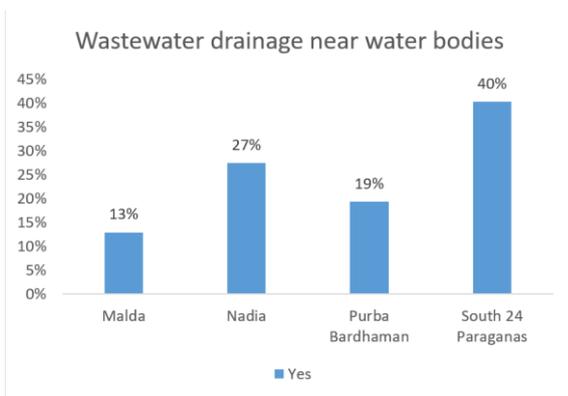
Figure 4.11: Wastewater drainage near water bodies (District-wise)

b. Figure mentioned below is with respect to the percentage distribution of Wastewater drainage found near 62 water bodies across 4 districts:

- Highest percentage of wastewater drainage was found near water bodies present in the South 24 Paraganas with 40 per cent.
 - Lowest percentage of wastewater drainage was found near water bodies present in the Malda with 13 per cent each.
- c. Figure mentioned below is with respect to the 'Drainage' near 62 water bodies assessed during the survey:

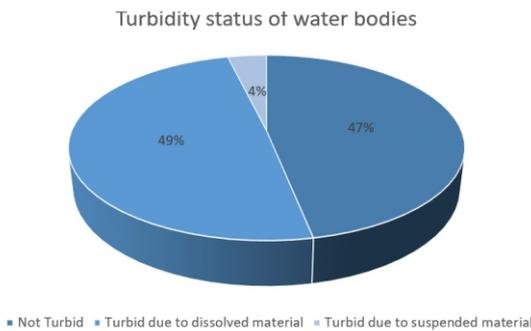
Figure 4.19: Turbidity status of water bodies

Figure 4.19 mentioned below is with respect to 'Turbidity (Beaker test)' of water present in 476 water bodies during assessment:

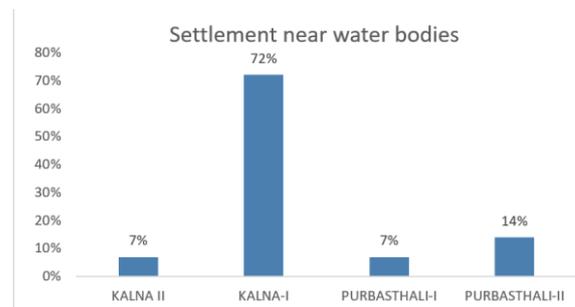
Figure 4.24: Settlement near water bodies in Purba Bardhaman

As high as 72 per cent of water bodies in Kalna-I are surrounded by settlements. 7 per cent of water bodies each in Kalna-II and Purbasthali-I blocks were surrounded by settlements.

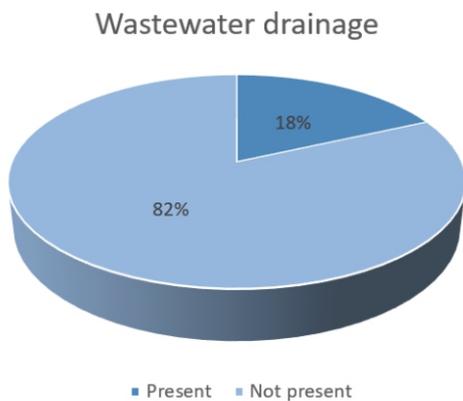
Figure 4.26: Wastewater drainage in and around water bodies in Purba Bardhaman

Pie-chart, Figure 4.26 represents Wastewater drainage present near water bodies assessed in Purba Bardhaman where 18 per cent of the water bodies get contaminated through wastewater drainage as a cause of direct run-off.

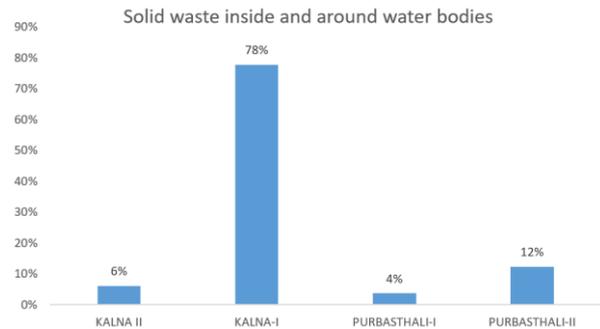
Figure 4.27: Solid waste inside and around water body in Purba Bardhaman

- As high as 78 per cent of water bodies in Kalna-I have solid waste present in/around them.
- Purbasthali-I accounts 4 per cent of water bodies having solid waste present in/around them.

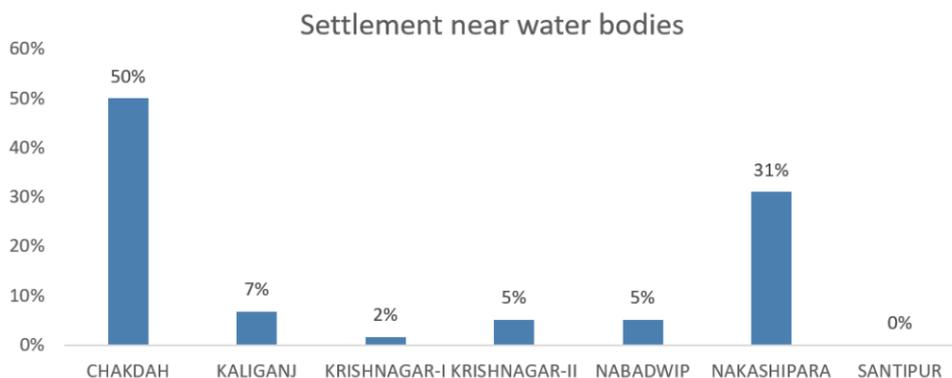
Figure 4.34: Settlement near water bodies in Nadia

Figure 4.34 depicts block-wise 'Percentage distribution of Settlement' found in Nadia district. 100% accountability has been captured under 7 blocks with a total count of 41 Water bodies, having settlement present within 200-250 meters of its radius. Highest percentage of settlements were found around the water bodies in Chakdah block and least in Krishnagar-I. No settlement was available near water bodies, which were found in Santipur block.

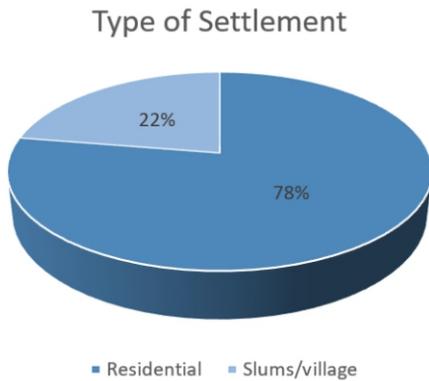
Figure 4.35: Type of Settlement around water bodies in Nadia

Figure 4.35 configures two types of settlement, which denotes that 78 per cent of water bodies in Nadia district is surrounded by Residential type of settlement whereas 22 per cent of water bodies are surrounded by Slum/village.

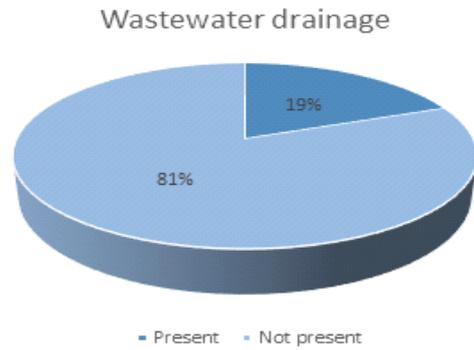
Figure 4.36: Wastewater drainage in and around water bodies in Nadia

Pie-chart, 4.36 represents Wastewater drainage present near water bodies assessed in Nadia where 19 per cent of the water bodies get contaminated through wastewater drainage as a cause of direct run-off.

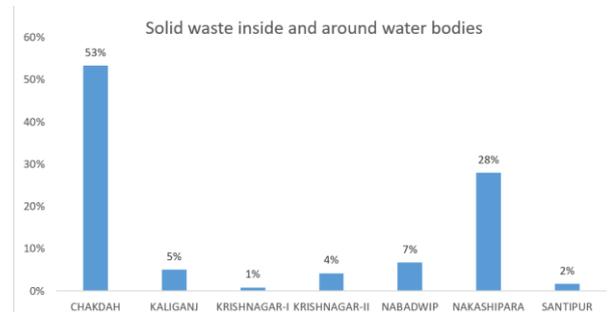
Figure 4.37: Solid waste inside and around water body in Nadia

- Highest percentage (55 per cent) of water bodies had solid waste in and around them in Chakdah.
- 28 per cent of water bodies in Nakashipara solid waste present in/around them.
- Krishnagar-I and Santipur accounts 1 and 2 per cent of water bodies with solid waste present in/around them.

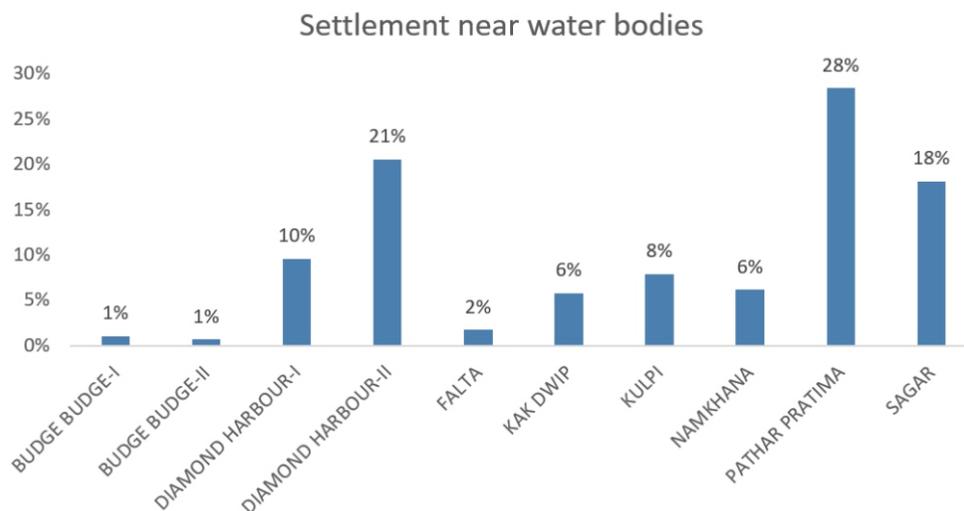
Figure 4.44: Settlement near water bodies in South 24 Paraganas

Highest percentage of settlements around the water bodies are found in Pathar Pratima (28 per cent) and lowest in Budge Budge-I and Budge Budge-II (1 per cent).
