# Identification and Estimation of River Bank Erosion along Brahmaputra and Barak Rivers in Assam during 1996-2002 using Satellite Remote Sensing Techniques.

December 2004

*Water Resources Division  
RS & GIS Applications Area  
National Remote Sensing Agency  
Hyderabad*

*Superintending Engineer  
Hydrological Observation Circle  
Central Water Commission  
Guwahati, Assam.*

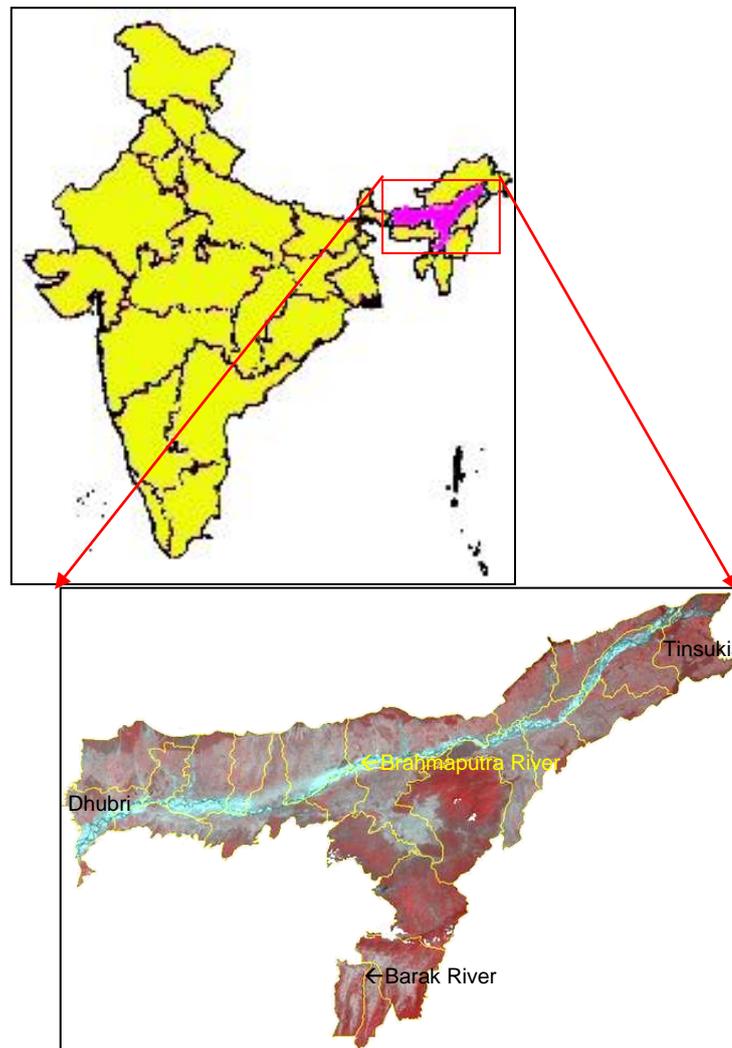
Figure-1: Location of the study area

The study area is the main Brahmaputra reach from Sunpura in Tinsukia district to Patakata in Dhubri district and Barak River from Rabipur in Cachar district to Katakhal in Karimganj district in Assam as shown in Figure-1. The Geo-graphical extent of the study area is shown in Table-1. The study area is covered in about 50 topomaps on 1:50,000 scale. The entire study area is covered in thirty seven plates on 1:50,000 scale and 2 plates on 700,000 scale and in one plate on 1Million scale for a complete overall view. A total of 80 satellite image plates were designed both for 1996 and 2002 years respectively and 40 erosion maps were designed showing the river bank erosion during 1996-2002.

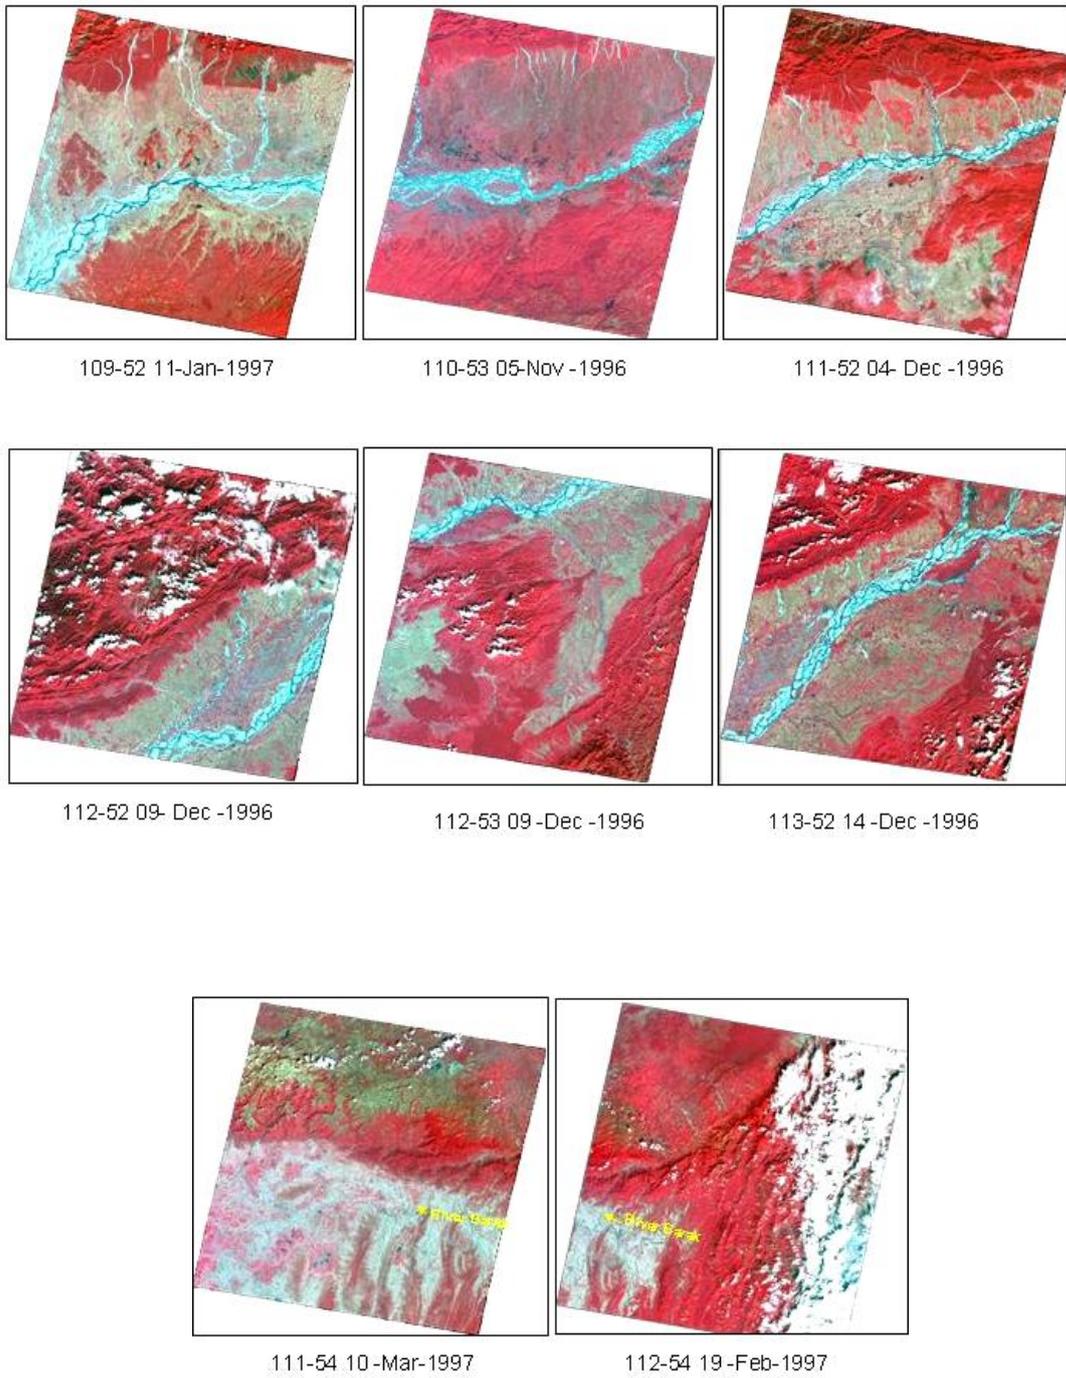
Figure-2: Satellite data of the study area for the year 1996

IRS-1C and IRS-1D satellites which were launched during December 1995 and September 1997 respectively have LISS-III sensor, whose characteristics were shown in Table-2. Post flood season satellite data of IRS-1C/1D LISS-III sensor which has a spatial resolution of 23m was procured to carry out the study. Wherever post flood season satellite data during November/December was not available, January and February data of the succeeding year was procured as shown in Table-3. Resampled images of the satellite data of different paths and row for the year 1996 are shown in Figure-2.

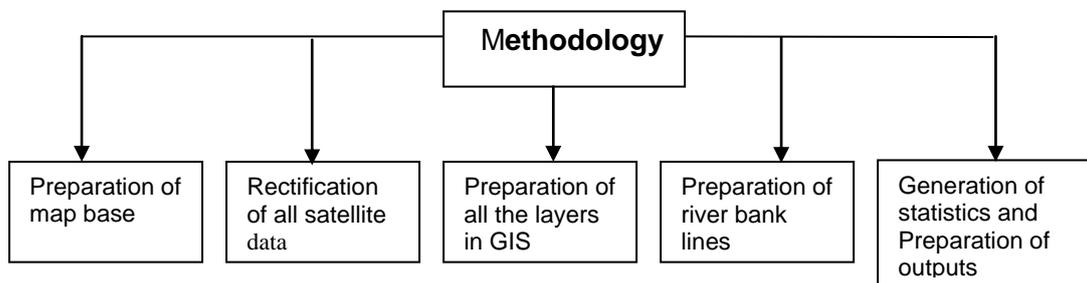
Figure-3: Schematic representation of the methodology

The methodology can be broadly categorized into five major steps as shown in Figure-3. The steps followed in the analysis of the study are shown as flowchart in Figure-4.

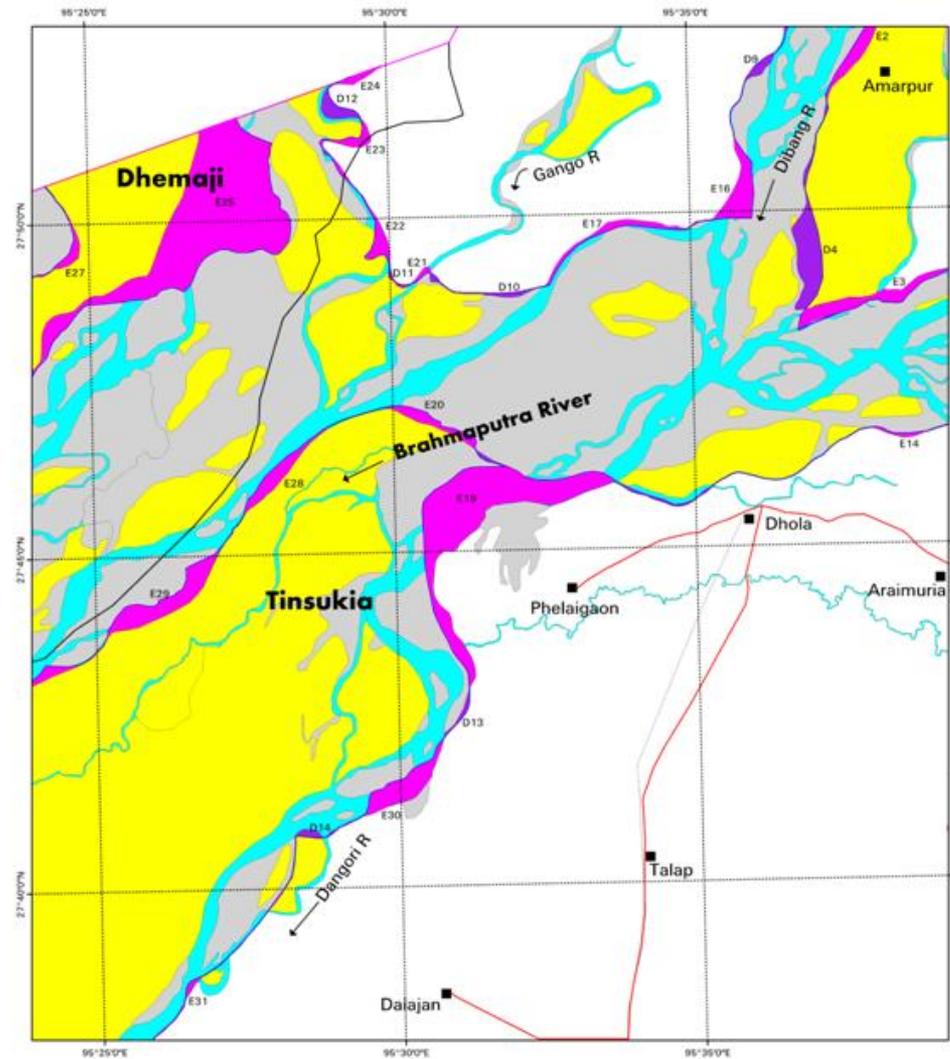
Plate 3

Map showing Erosion and Deposition during 1996-2002

River Bank Erosion (E) and Deposition (D) Statistics  
(Area less than 5 hectares not included)

S.No	Location	Area (ha.)
1	E5	116
2	E16	180
3	E17	28
4	E18	438
5	E20	53.5
6	E22	46
7	E23	28
8	E24	17
9	E25	1165
10	E27	57
11	E28	45.5
12	E29	148
13	E30	130
14	E31	7.7
15	D4	145
16	D9	18
17	D10	15
18	D11	5
19	D12	26
20	D13	10.6
21	D14	13

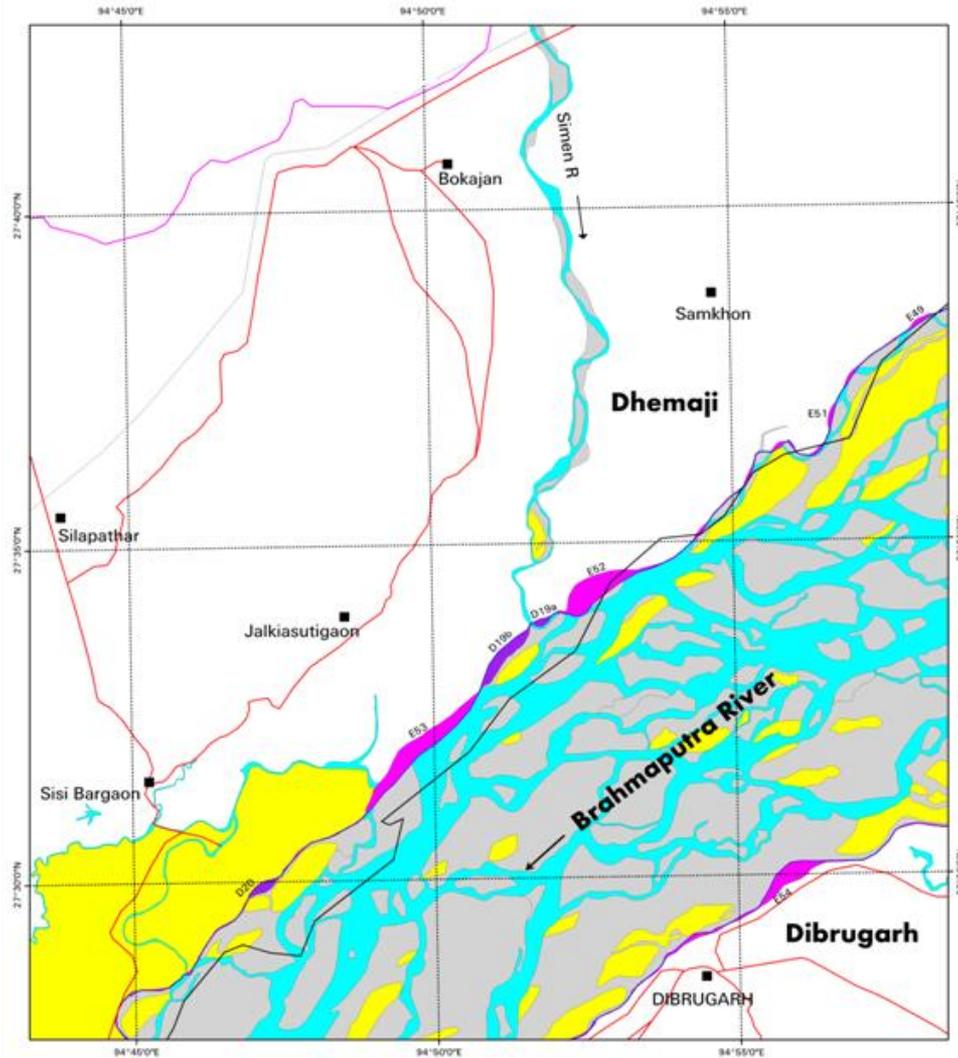
Plate 8

Map showing Erosion and Deposition during 1996-2002

River Bank Erosion (E) and Deposition (D) Statistics  
(Area in Ha. is tentative and subject to change)

S.No	Location	Area (ha.)
1	E49	7
2	E51	6.7
3	E53	118
4	E52	141
5	E54	80
6	D19a	7
7	D19b	49
8	D20	14

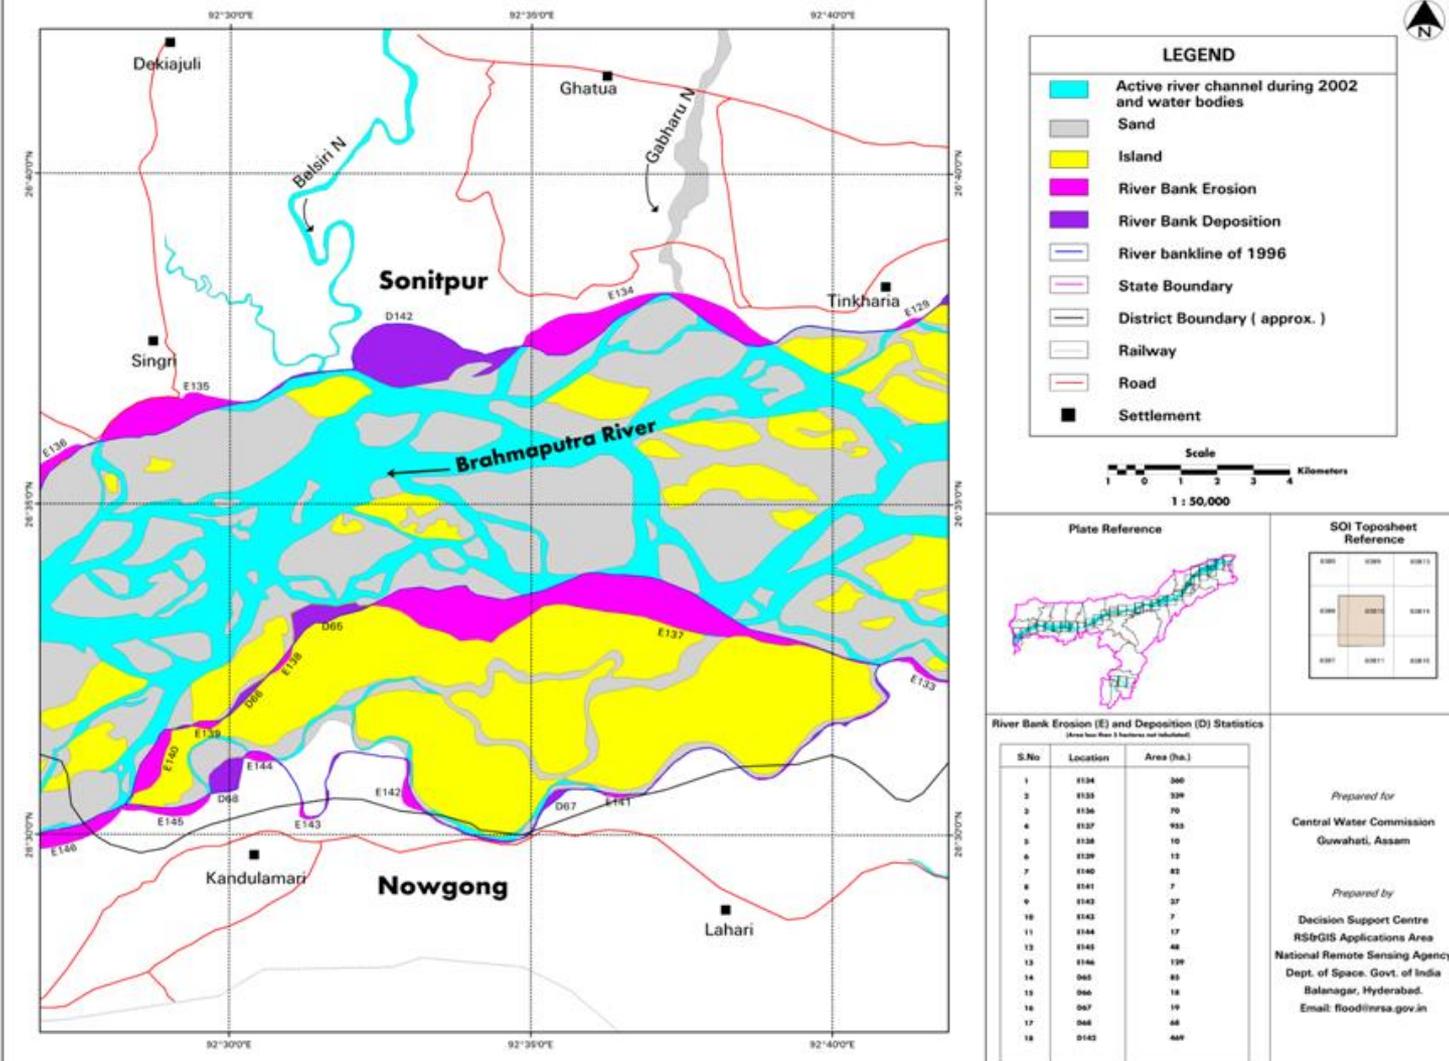
Plate 21

Part of Nowgong and Sonitpur districts

Map showing Erosion and Deposition during 1996-2002

9. Maximum deposition was found at  $92^{\circ} 32' 50''$  E and  $26^{\circ} 37' 15''$  N in Sonitpur district as shown in Plate-21 and the deposited area was 469 hectares

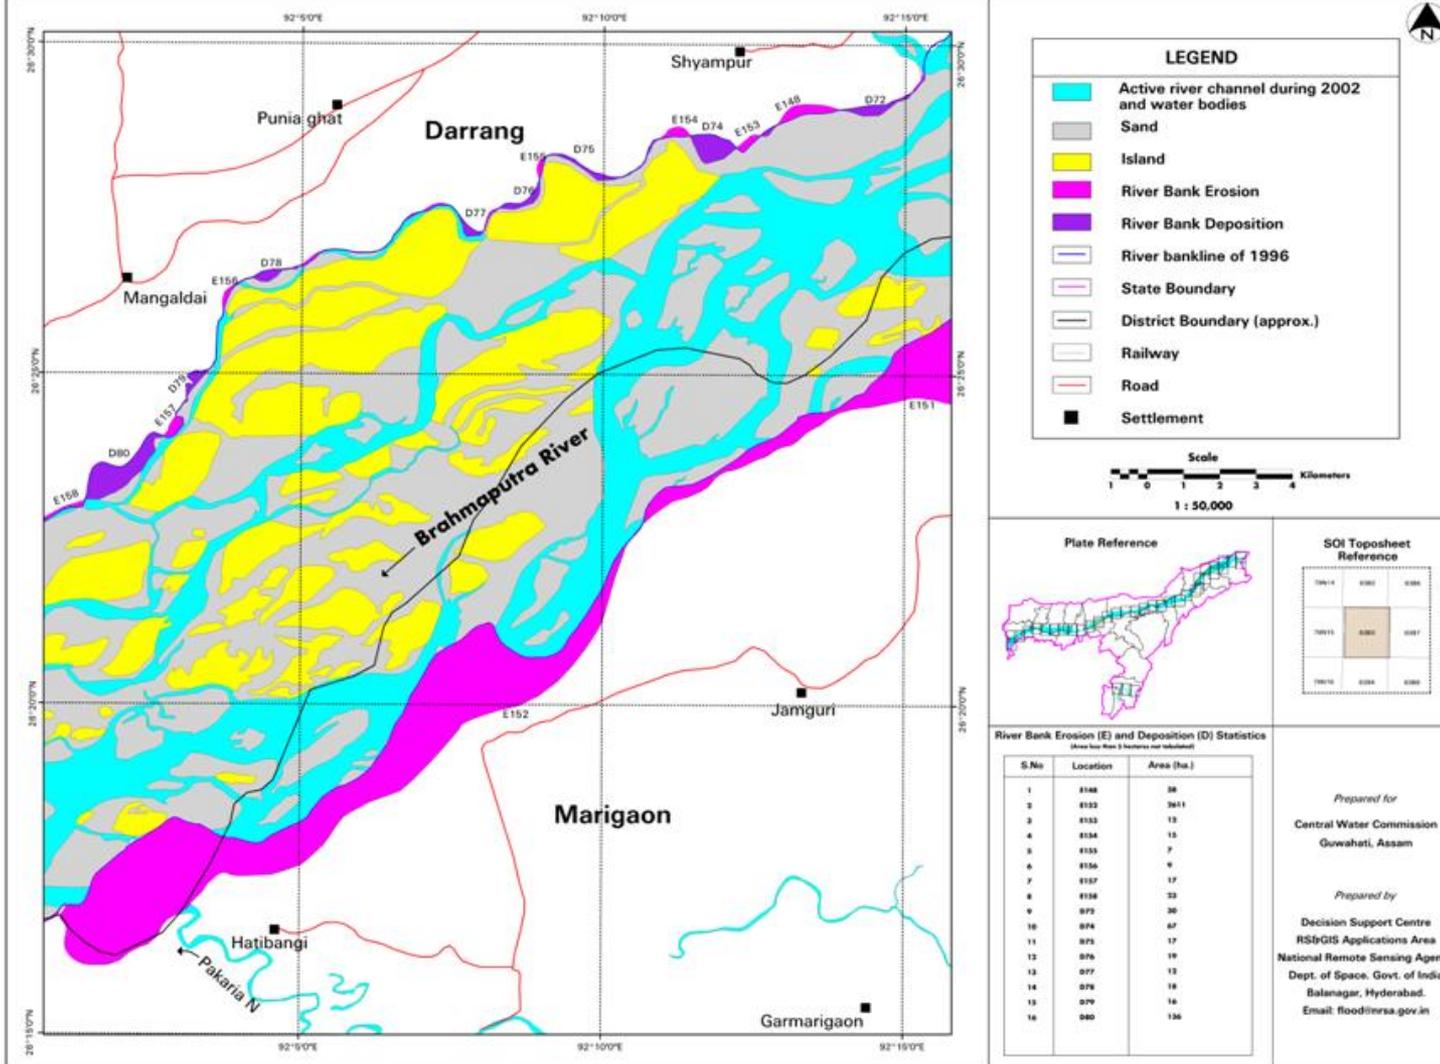
Plate 23

Part of Marigaon and Darrang districts

Map showing Erosion and Deposition during 1996-2002

7. The total area of deposition along Barak River only during 1996-2002 was found to be 159 hectares
8. Maximum erosion was found at  $92^{\circ} 02' 24''$  E and  $26^{\circ} 17' 09''$  N in Marigaon district as shown in Plate-23 and the eroded area was 2611 hectares
