Sponsored Thesis Project Competition on
“RE-IMAGINING URBAN RIVERS”
Season- 2

Project Title: METAMORPHOSIS – Ecological Restoration and Development of an abandoned quarry, a case of ARAI Stone Quarry, Pune

Creator : Sanika Upasani, B. Arch.

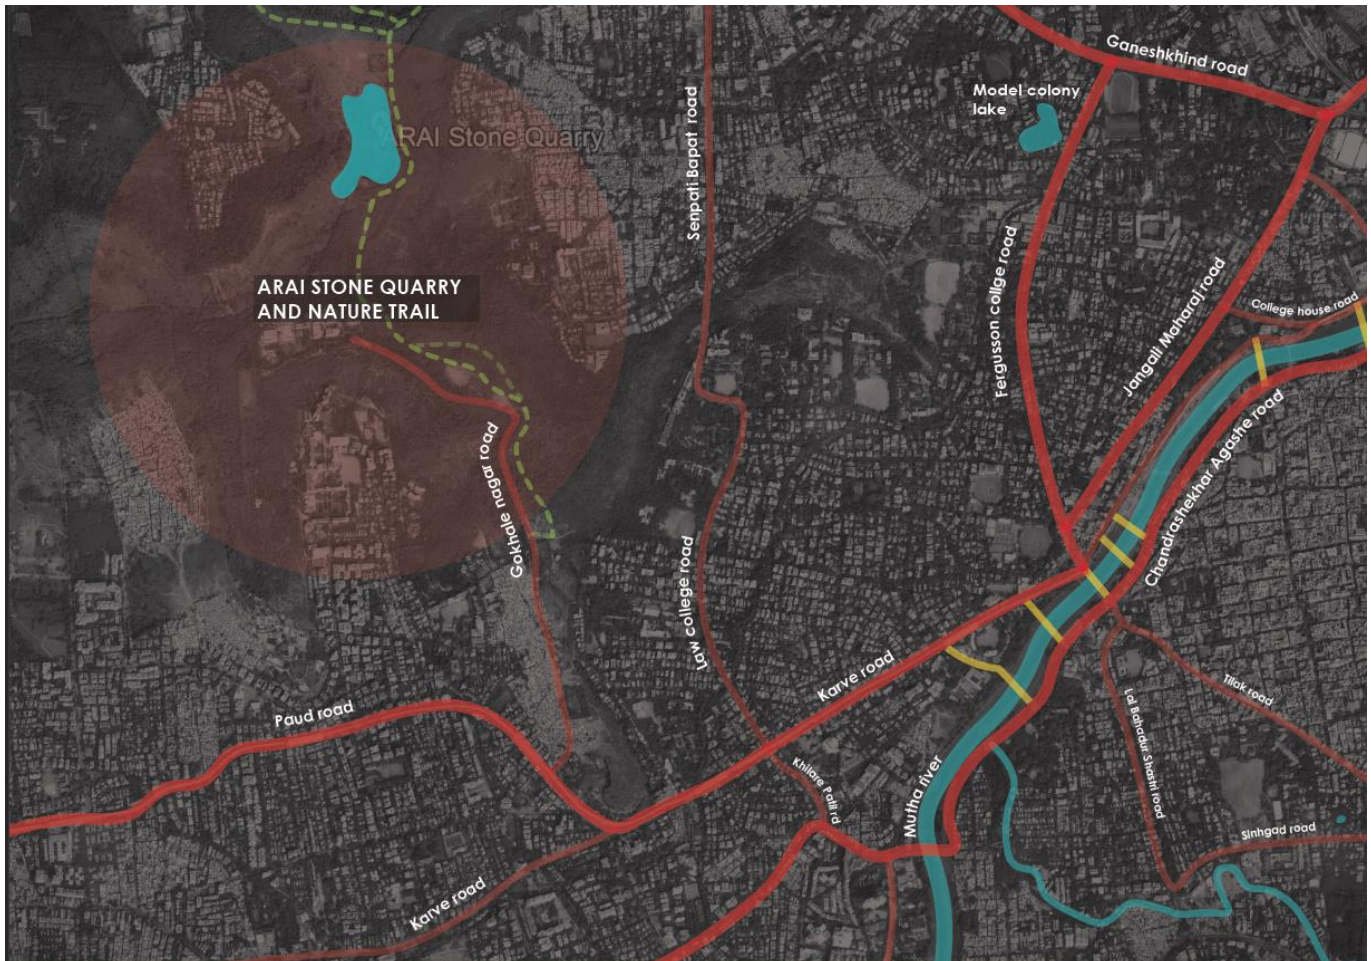
Fig 14 – Primary, Secondary and tertiary Road Network around ARAI Stone Quarry

Primary Road is the Karve Road which later converts to Paud Road. Karve road branches out into Gokhale Nagar Road which is 9 mts wide and leads up to the ARAI Office. After this secondary road, the Nature Trail starts.

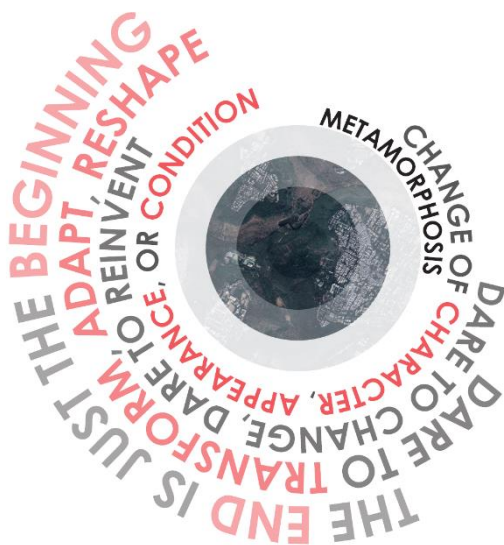
Fig 19 –

Upper - Proposed zoning along the ARAI Nature Trail

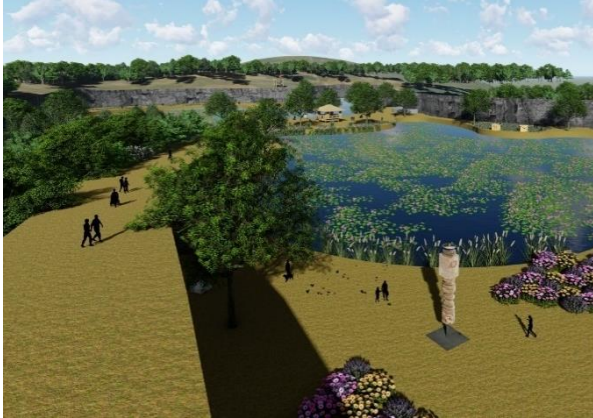
01

Entry ramp leading to the quarry

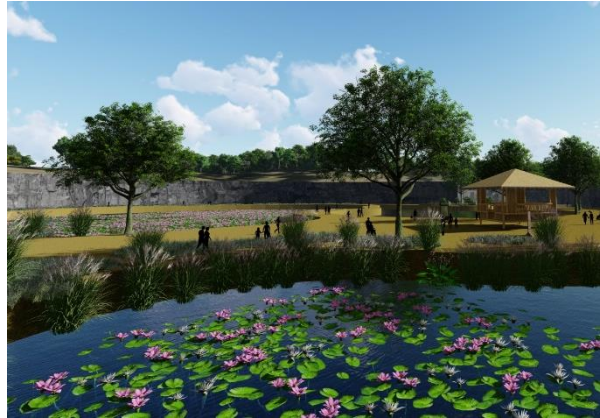
02

Information pavilion and water lily and lotus plantations

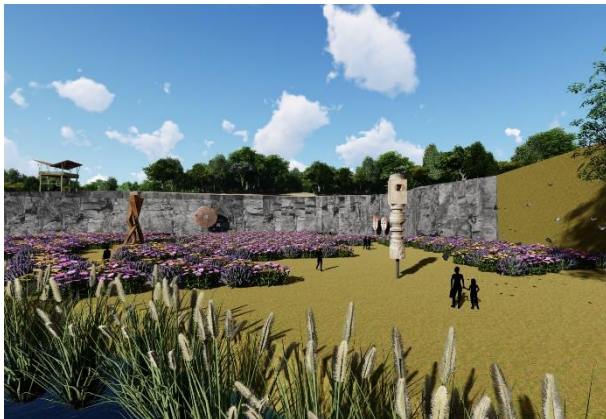
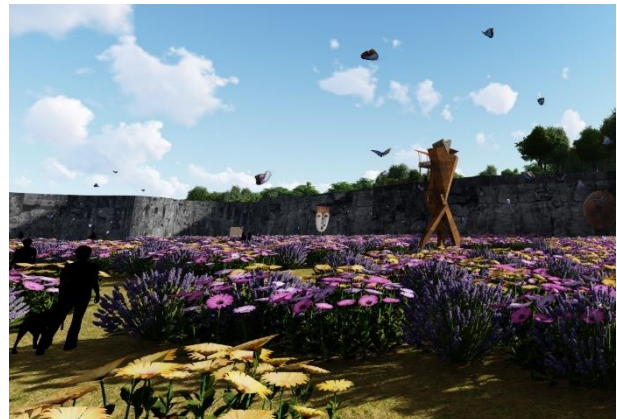
03

Open air sculpture park and butterfly garden

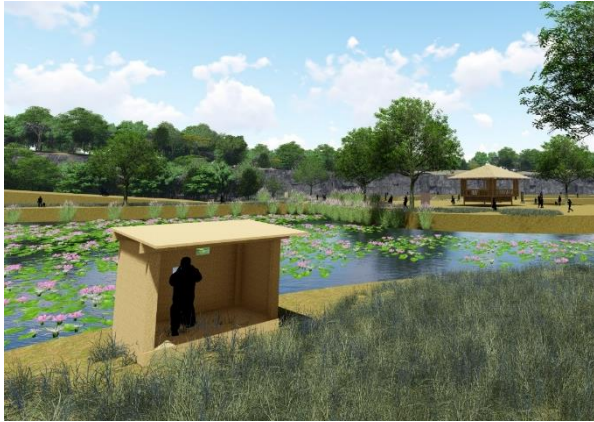
04

Bird watching blinds

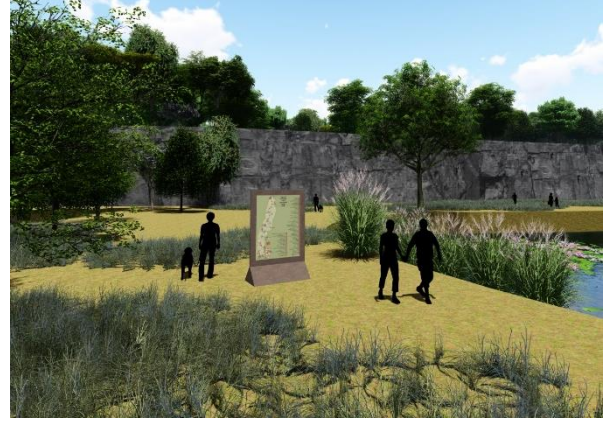
05

Herbal garden and rock-climbing activities

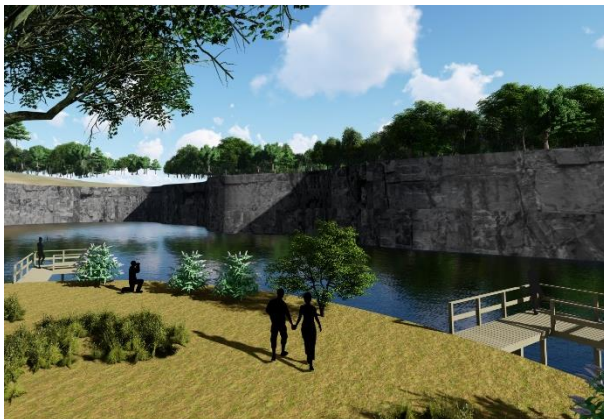
06

Decks for fishing (Pisciculture)

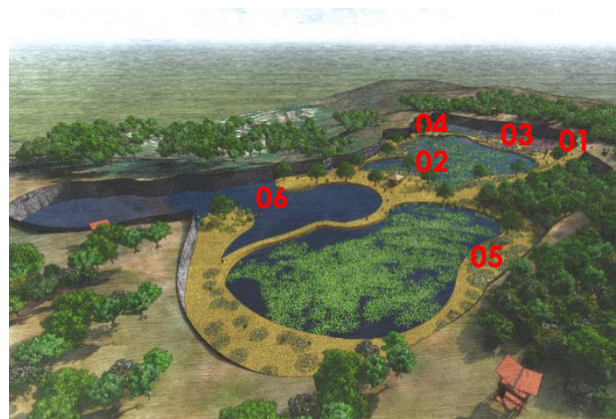
Aerial view of the quarry

Fig 22 – Proposed 3D views of the Quarry Watering Hole

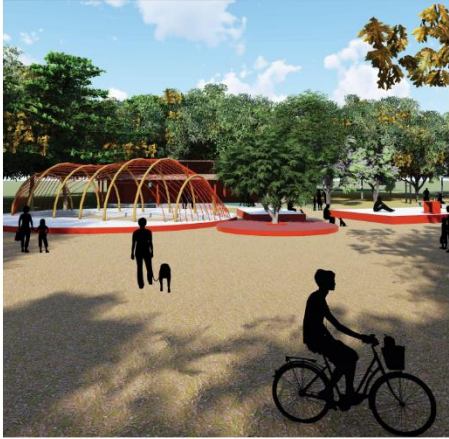
View of the rope pavilion, the existing plinths and the cycle track

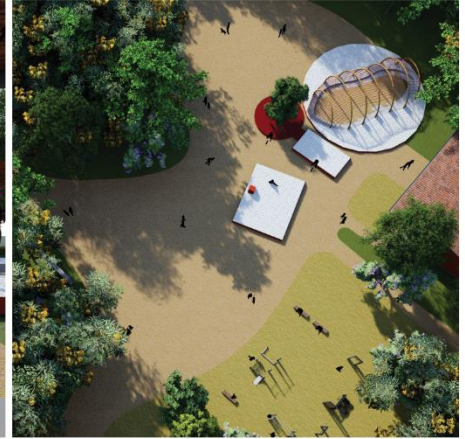
Aerial view of the rope pavilion showing the plinths, exercising space and the toilet block
