REPORT OF REFURBISHMENT OF ENCLOSURE III AT KACHUA PUNARVAAS KENDRA, SARNATH

ACTIVITY UNDER COMPONENT IV (RESCUE AND
REHABILITATION) OF THE WII-NMCG PROJECT TITLED:
BIODIVERSITY CONSERVATION AND GANGA REJUVENATION

November 2019

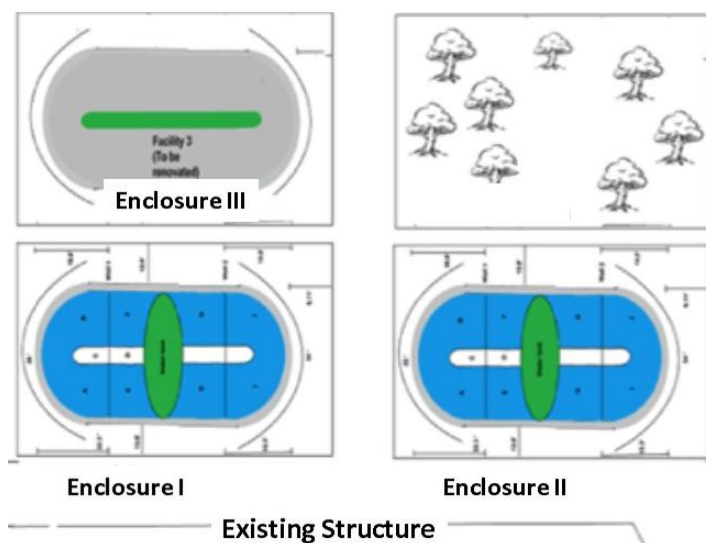
- Enclosure 1: The enclosure is used to house critically endangered *Batagur dhongoka* and *B. kachuga* including the juveniles from 2019 batch (202) that have hatched at the centre.
- Enclosure 2: The enclosure is used for housing confiscated turtles that are often of multiple species; however, poor water retention due to seepage limits its effective use. The same has been made functional by carrying out minor repair works; however, further repairs are required to meet future emergencies.
